Yieh United Steel Corporation (YUSCO)

Improvement in safety protection

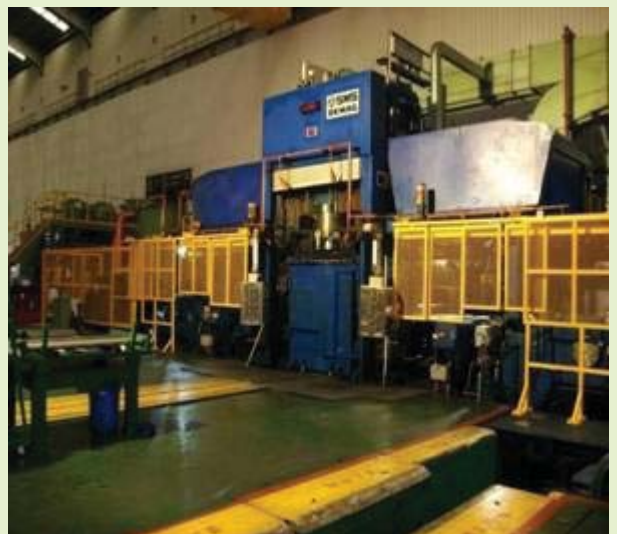
A safety net has been fully installed around the rolling mill. This ensures that in abnormal situations, or when the strip is broken, no personnel will be harmed.

- Boards were immediately put in place to act as temporary protection. If the strip breaks again when the rolling mill is in production, the steel plate is blocked and will not hurt our personnel.
- Health and safety training for the personnel in the unit was reinforced to enhance their awareness.
- The cause of the sudden power failure was analysed and an improvement plan developed as a result.
