JFE Steel

Safety improvement during roll change operation

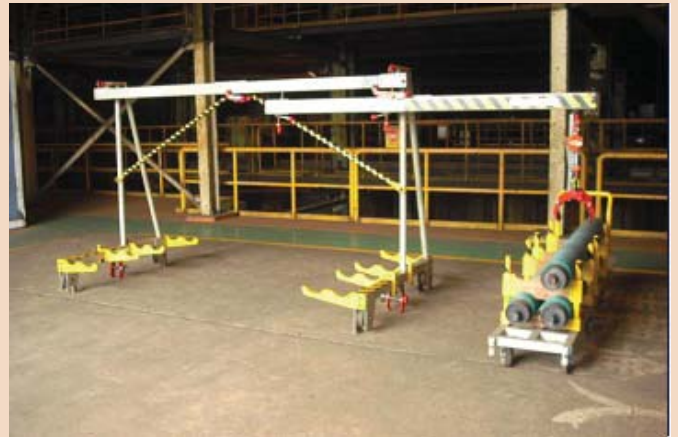
To improve the operation, JFE developed a carriage for use during the roll change. The carriage can be easily assembled and disassembled at the deck of the pickling tank.

The new roll-change equipment

The installation of the new roll changing equipment has led to significant safety and efficiency improvements including:

- Roll balancing and dangerous manual operations have been eradicated.
- The removal of these dangers has changed the risk level for this operation from level 3 to level 1.
- The time taken to change all five rolls on the looper dropped from six hours to two hours and forty minutes.
