A Workable, Lasting Solution for Water Losses through Leaking Water Pipes

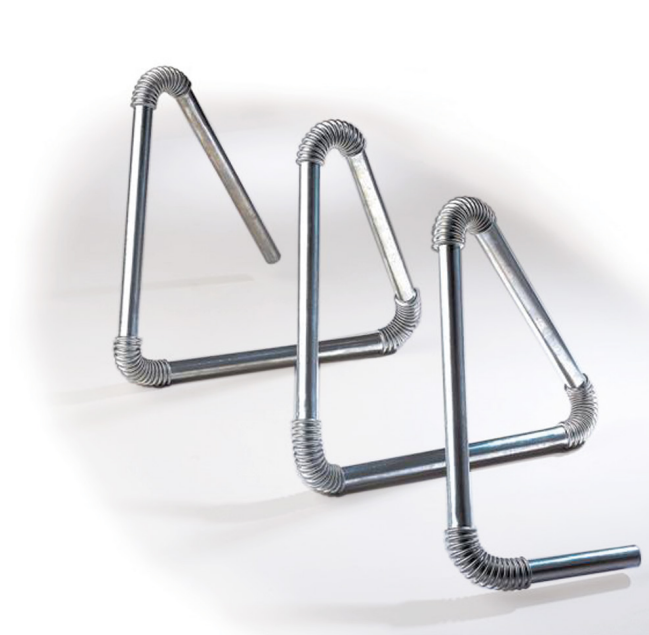
*Corrugated stainless steel pipes.
Source: Korea Water Works Association (kwwa.or.kr)*

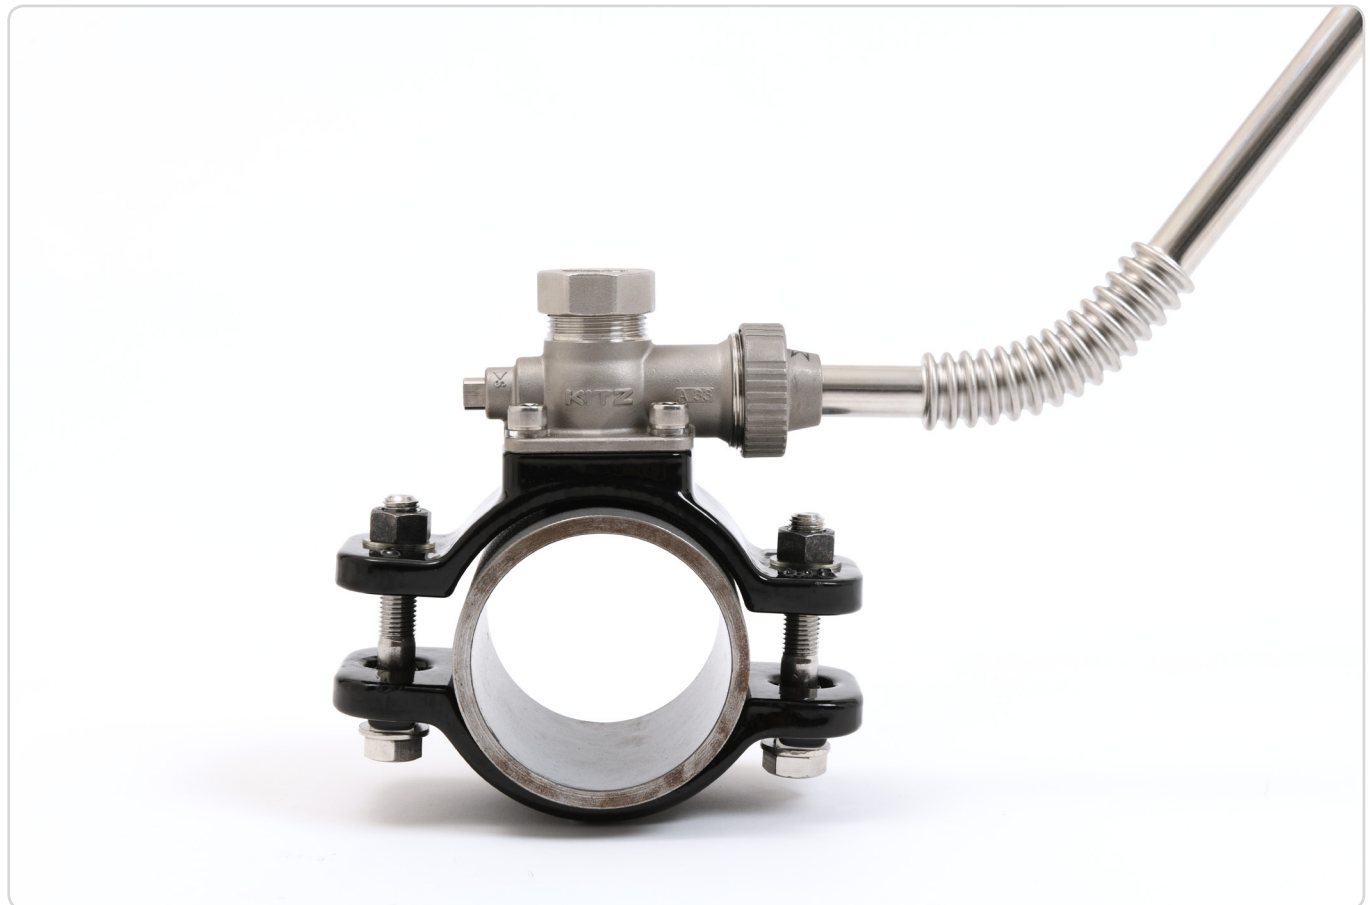
*Saddle used with the stainless steel corrugated pipe system
Photographer: Philippe De Putter*

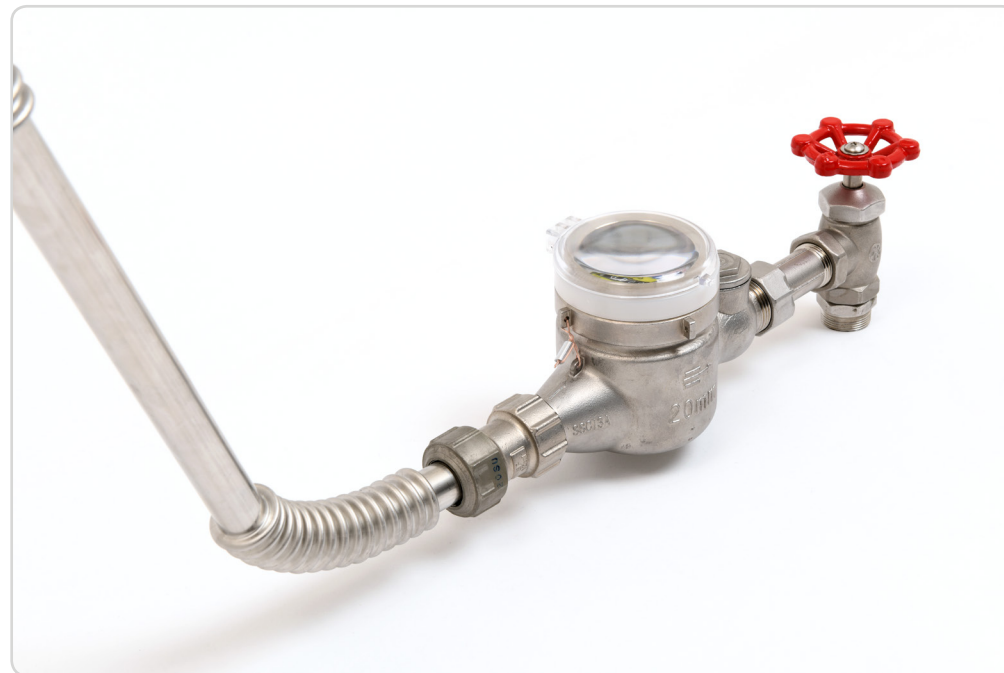
*Flow meter and stopcock with the stainless steel corrugated pipe system
Photographer: Philippe De Putter*

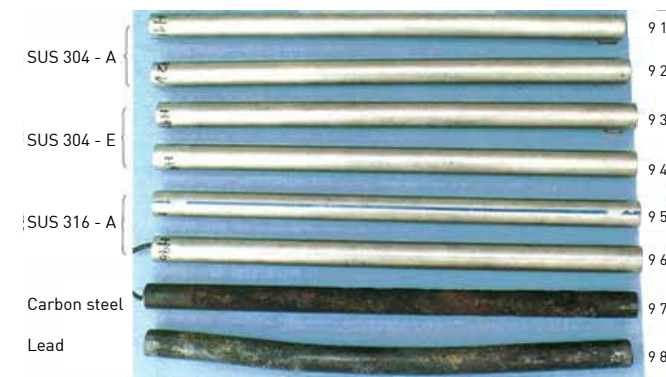
1. Kushiro city, test No. H; after acid pickling

Photos of the burial test results after 10 years of burial in Kushiro (North-East Japan) and Kuwana (Central Japan).

The tests showed that stainless steel had performed better in terms of strength and corrosion resistance with grade 316 performing better than 304. The Cl⁻ and SO₄²⁻ concentrations in the soil were very high. The tests showed no evidence of pitting corrosion on the 316 samples.

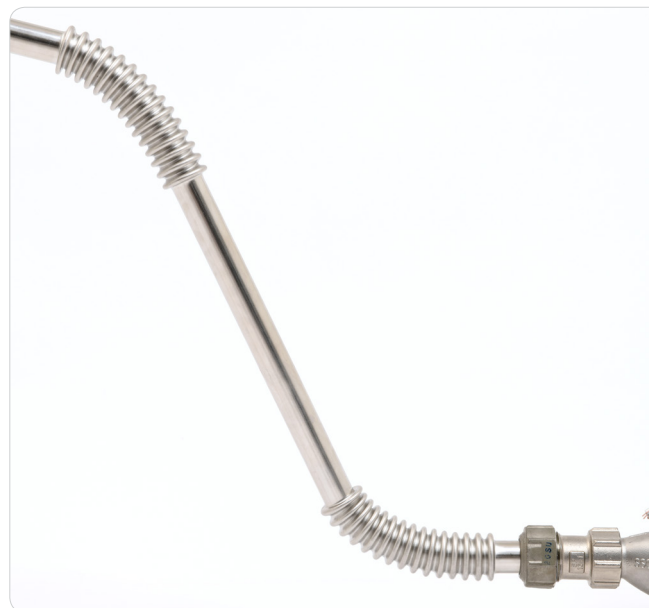
Stainless Steel Corrugated Pipe
Photographer: Philippe De Putter
