Yieh United Steel Corporation (YUSCO)

Preventing fires during transportation of the slag pot

Award: Safety
Category: Workplace improvement

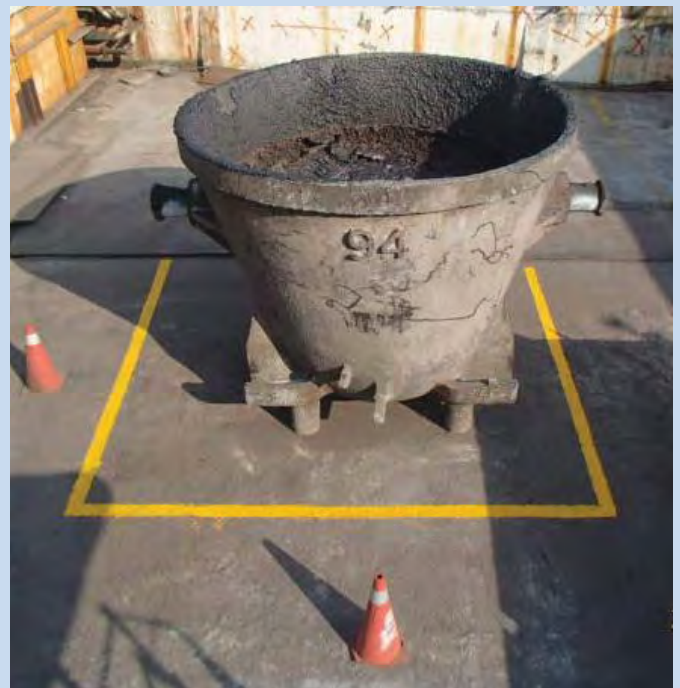
Liquid steel and slag splashed out of the slag-pot due to vibrations during transport. The molten steel and slag caused a large fire and damaged the slag-pot car.

The slag pot cannot be filled above the cylindrical protrusion which is used to tip the pot

The standard operating procedures (SOP) for slag-pot transportation were modified. The SOP now states that the pot cannot be filled above its maximum limit, and that the slag-pot should be set aside for one hour after it is removed from the filling position. It can then be sent for disposal in the slag-pot car.

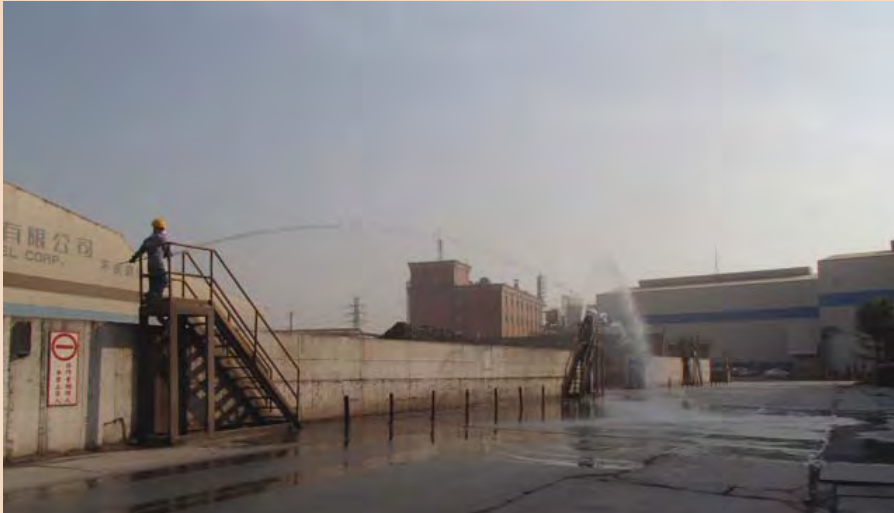
A series of 33 overlapping fire hydrants have been installed along the vehicle's path in case of a slag splash during transportation

A series of 33 fire hydrants were installed along the slag-pot car's path. The range of each hydrant overlaps in case steel or slag splash out during transportation.

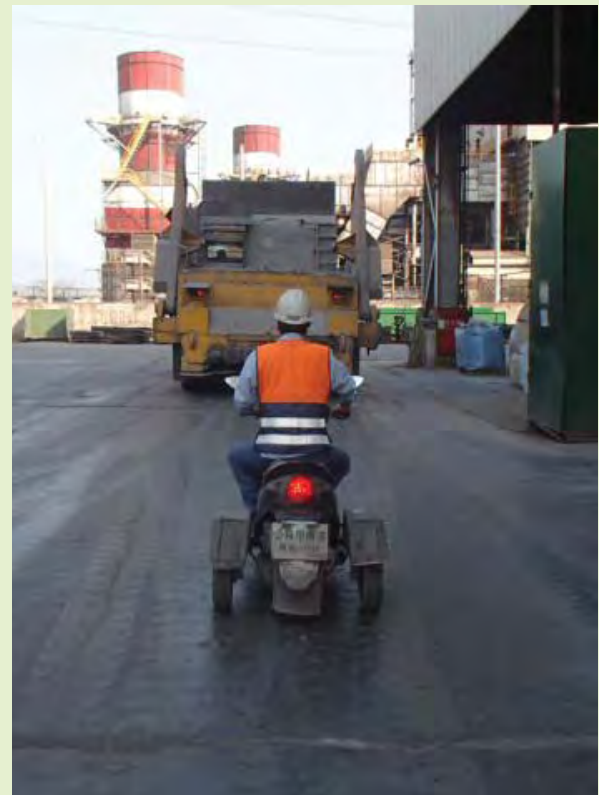
A safety person rides behind the slag-pot vehicle during transportation

Lastly, one person rides a bicycle behind the slag-pot car during transportation. This person can react immediately in case an accident occurs.
