Nippon Steel & Sumikin Stainless Steel Corporation

Award: Safety
Category: Workplace improvement

Prevention of injury accidents in machine operating area of gate type hoist

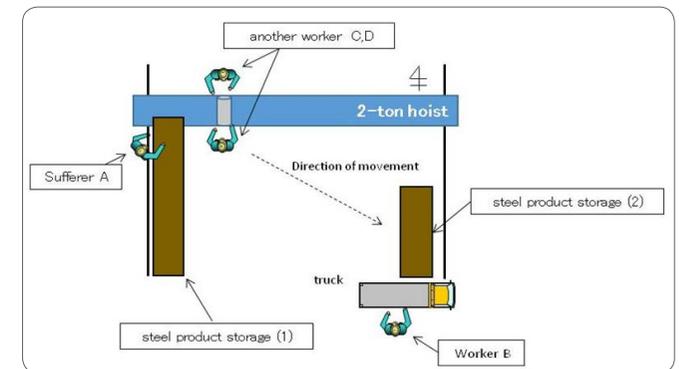
Figure 1: Positional relationship at the time of disaster

The hoist is used by multiple construction companies to process and store materials. The injury accident in 2016 occurred during a worker was operating the hoist. Another worker of different company walked in the rail to find some material. At that time, his toe was pinched by the moving wheel of the hoist (Fig1).

We installed safety fences around the rails of the hoist to restrict operators to walk in. Moreover, the entrances of the fences are locked so that only workers from hoist management company can enter.
