## Road bridge refurbishment

### Nou, Itoigawa, Niigata Prefecture, Japan

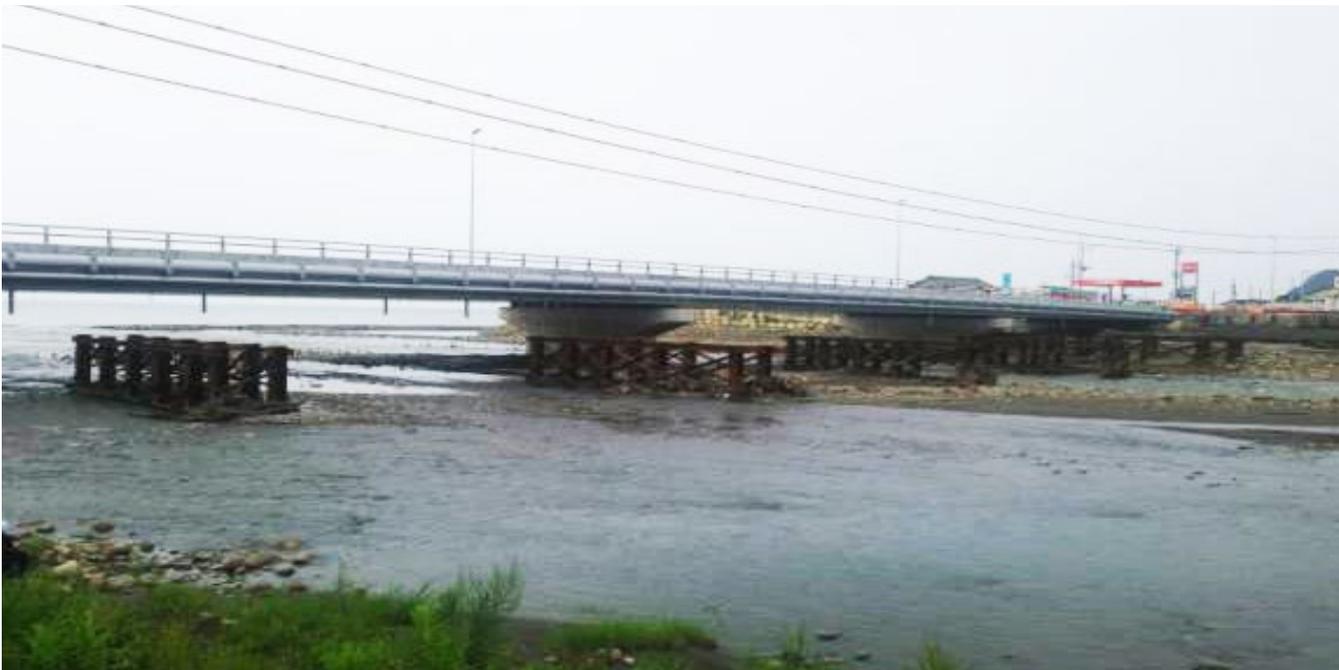
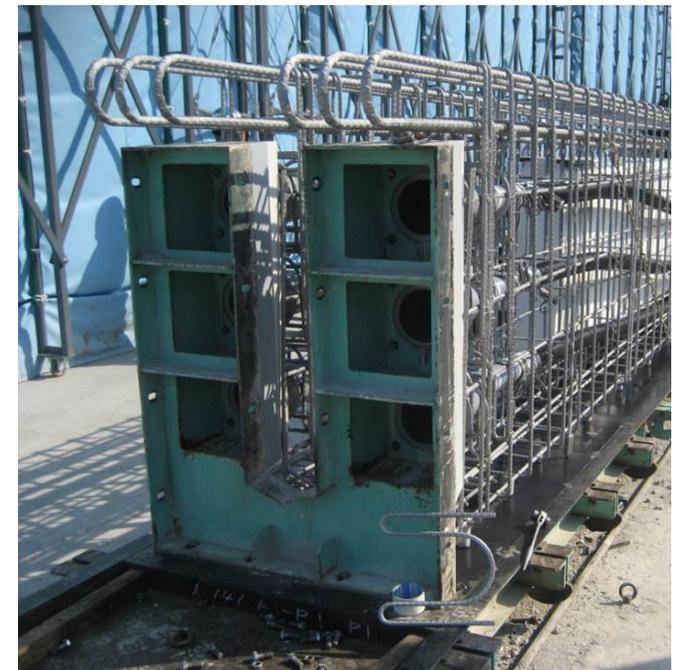
The concrete road bridge of a coastal road in the West of Japan had developed severe corrosion in its formwork. Besides the chloride-bearing marine atmosphere, the use of de-icing salts in winter was another cause of the damage. For the refurbishment of the bridge, the selective use of ferritic stainless

steel was a rational and cost-saving choice. Out of the four spans of the bridge structure, the exposed outer two needed to be replaced. The new concrete spans were cast on site and reinforced with type SUS410 stainless steel, which ideally fulfilled both the corrosion resistance and cost reduction requirements. While the use of stainless steel reinforcement in new roads and bridges is not uncommon, this case shows that the stainless steel option is also technically and economically viable in repair and renovation.
