Road bridge refurbishment

Nou, Itoigawa, Niigata Prefecture, Japan

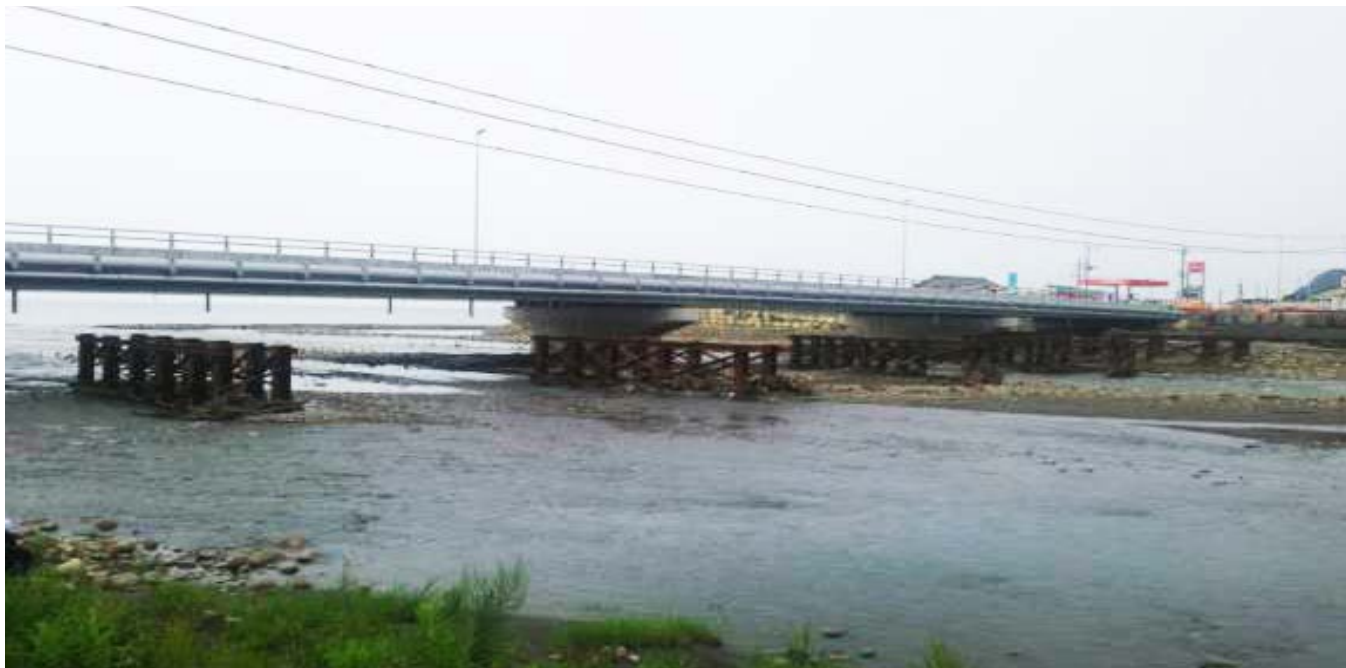
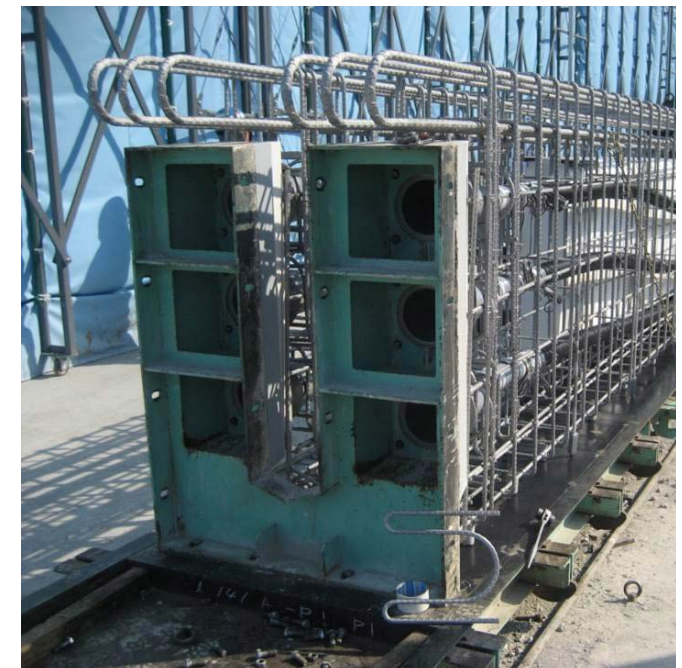
The concrete road bridge of a coastal road in the West of Japan had developed severe corrosion in its formwork. Besides the chloride-bearing marine atmosphere, the use of de-icing salts in winter was another cause of the damage. For the refurbishment of the bridge, the selective

use of ferritic stainless steel was a rational and cost-saving choice. Out of the four spans of the bridge structure, the exposed outer two needed to be replaced. The new concrete spans were cast on site and reinforced with type SUS410 17% chromium stainless steel, which ideally fulfilled both the corrosion resistance and cost reduction requirements. While the use of stainless steel reinforcement in new roads and bridges is not uncommon, this case shows that the stainless steel option is also technically and economically viable in repair and renovation.
