## Tension rods in a footbridge

### New Delhi, India

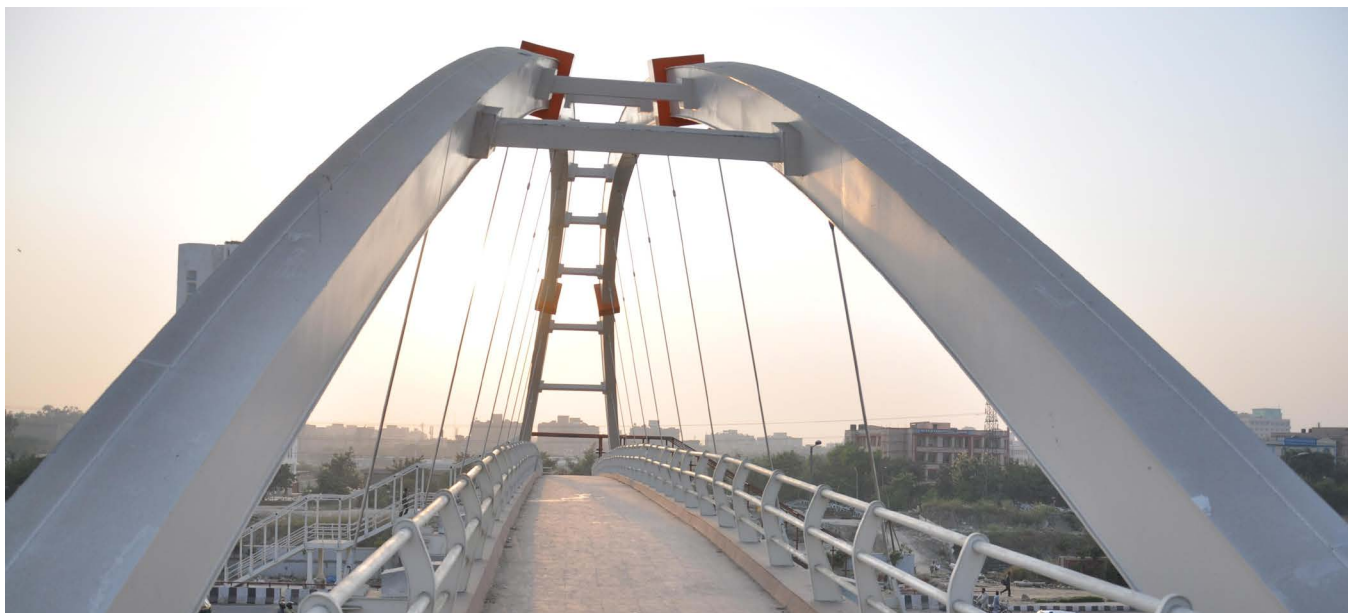
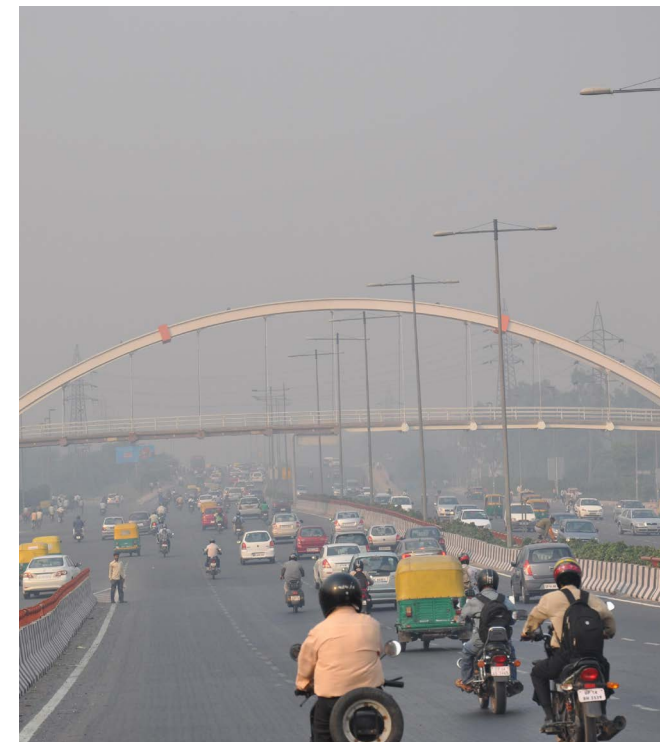
A footbridge spanning a major sixteen-lane road involves tension rods in 22% Cr 5% Ni duplex stainless steel. Urban pollution resulting from road traffic makes corrosion resistance an important criterion of choice.

Tension rods require particular attention: in the threaded end parts, zinc layers become difficult to apply with a reproducible and consistent thickness. Additional damage during

the installation process, which would make the threads susceptible to corrosion, cannot be excluded. In a busy urban environment, conventional steel would have required a dual metallic and organic protective layer to meet the durability requirements on bridges. The designers decided to use stainless steel tension rods for the structure that is otherwise made from hot dip galvanized and painted structural steel. The visual qualities of the stainless steel were an additional advantage because the footbridge is part of a major access route to a stadium and is regularly used by thousands of visitors.
