The Pavilion, Regent's Place

The Pavilion marks the new western entrance into Regent's Place, a 13-acre development in the heart of London which features retail, leisure and public spaces. It is a structure made entirely of stainless steel in which a field of vertical columns supports a roof canopy 8 m above street level. The pavilion is 20 m by 5 m in plan, with 258 highly slender rectangular hollow sections supporting a roof plane, reflecting sunlight during the day and projecting light at night from lights integrated into the paving. The structure was opened to the public in 2009 and won a 2010 Royal Institute of British Architects (RIBA) Award for architectural excellence.

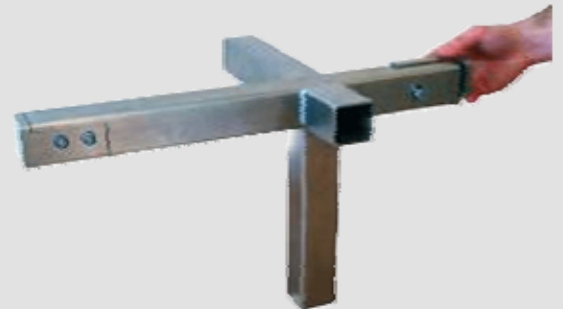
Figure 3: Mock-up of roof connection

Stainless steel is highly susceptible to weld distortion. To avoid issues arising from elements being out of tolerance, the whole superstructure was match fabricated with sections straightened after each welding procedure. To make the elements more manageable, the roof grillage was fabricated first with spigots (for attachment to the damper and the column section) prior to delivery on site.

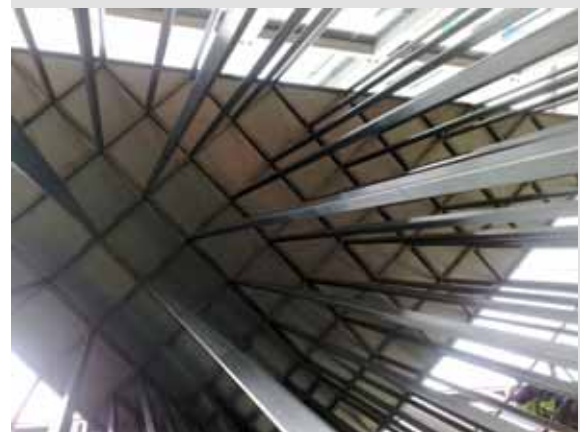
Figure 4: View of underside of roof

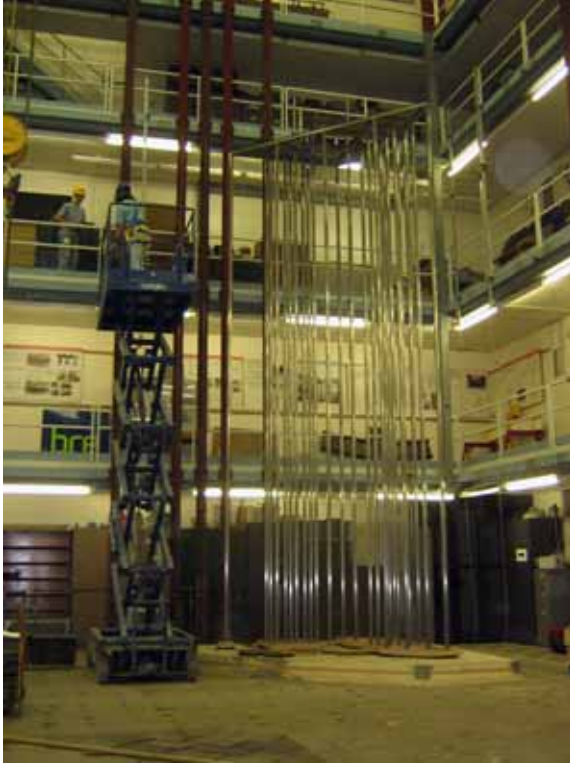
Figure 5: Mock-up of part of the pavilion at BRE

A 1:1 part mock-up was constructed at the Building Research Establishment's testing facility in Watford, UK, primarily to test the structure's dynamic response, both with and without the inclusion of impact dampers. Static tests were also conducted on the mock-up to enable the finite element models to be calibrated. The dynamic test consisted of a shaker that was attached to the column at mid-height. It was estimated from these tests that the intrinsic damping for the welded structure was as low as 0.2 % which is significantly less than that specified in BS 6399-2 [3] for a welded steel frame (typically a value of 0.4 % is adopted). The tests also enabled the structure's ability to resist vandal loading scenarios to be demonstrated, the proposed construction methodology to be tested and finishes and lighting to be determined.

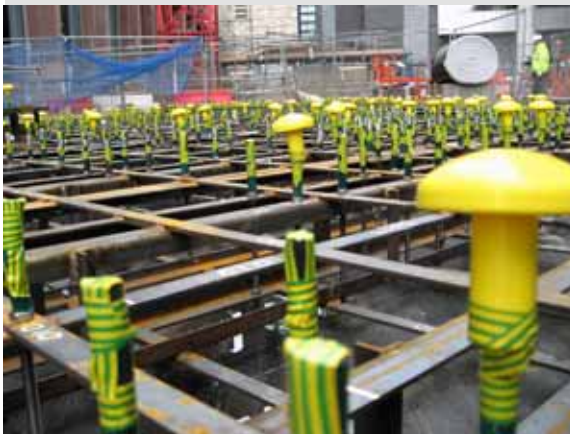
Figure 6: Bolt cage prior to concrete pour

1500 stainless steel holding down bolts were used to position the columns to very tight tolerances (± 1.5 mm). This was achieved by the use of a "bolt cage" (a network of carbon steel angles and flats) cast into the slab, which acted as reinforcement and held the bolts in position as the concrete was poured (Figure 6).

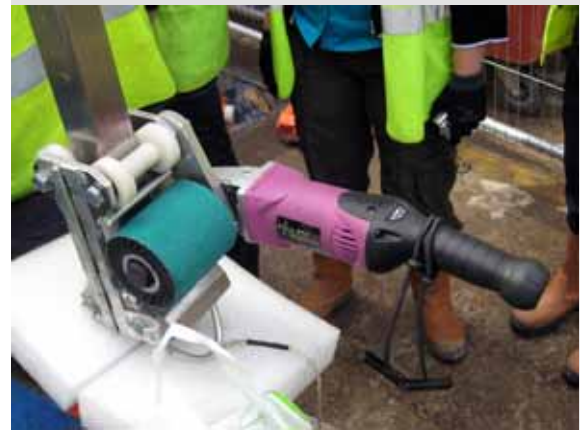
Figure 9: On-site polisher (“Rat up a drain-pipe”)

An adhesive plastic protective coating was applied along the length of the columns to protect them during transportation and erection [4]. Following completion of construction, a number of scratches to the column surface were evident at high level. A polisher was adapted such that it would automatically run up and down the height of the columns and remove any visible defects. This purpose-built machine was dubbed the “rat up a drain pipe” and ensured the full beauty of the elegant, impossibly slender columns was achieved.
