Supporting presentation for lecturers of  
Architecture/Civil Engineering

**Chapter 07A:**  
**Structural Applications of**  
**Stainless Steel Reinforcing Bar**

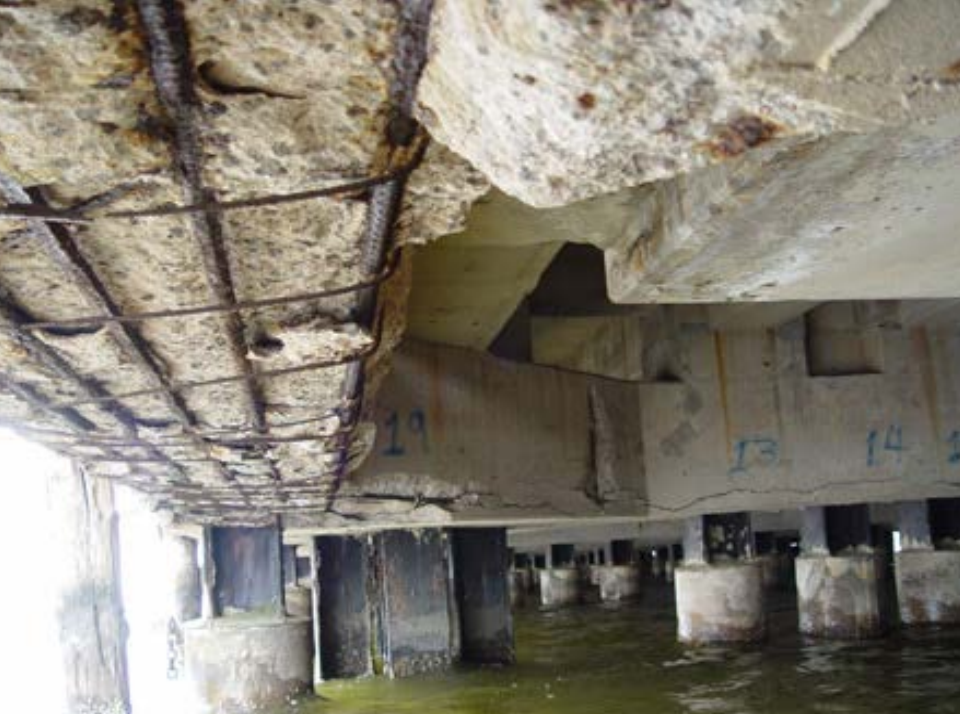
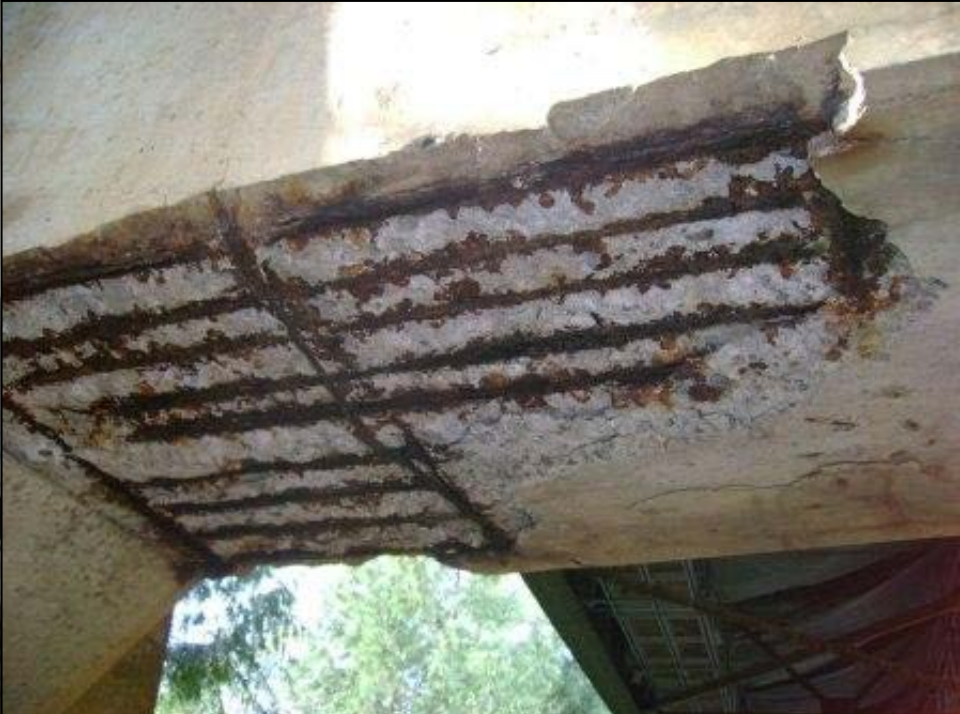
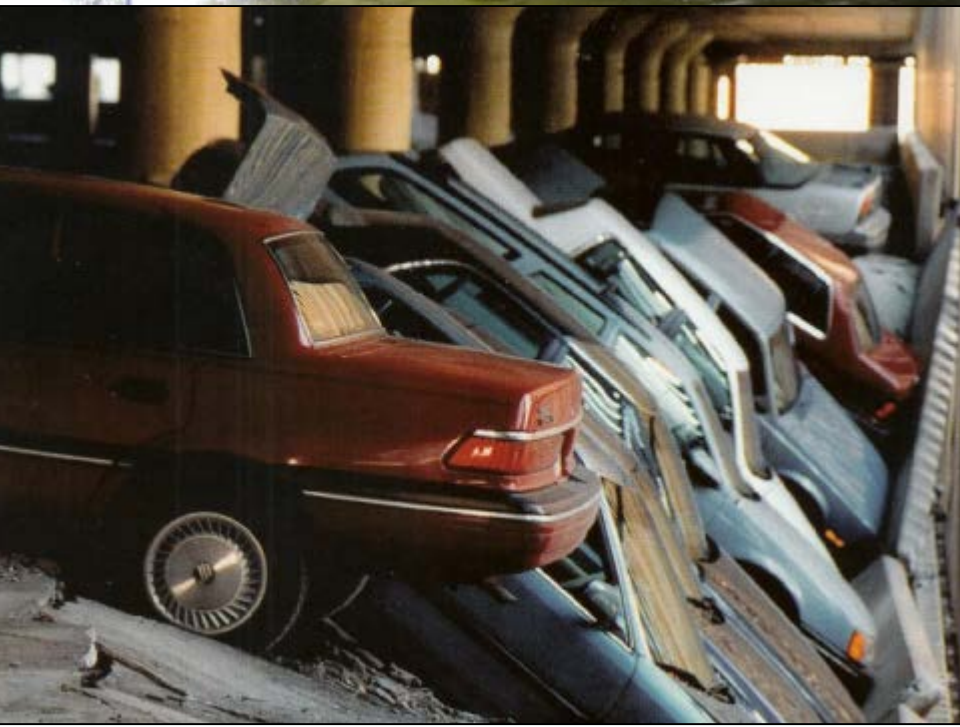
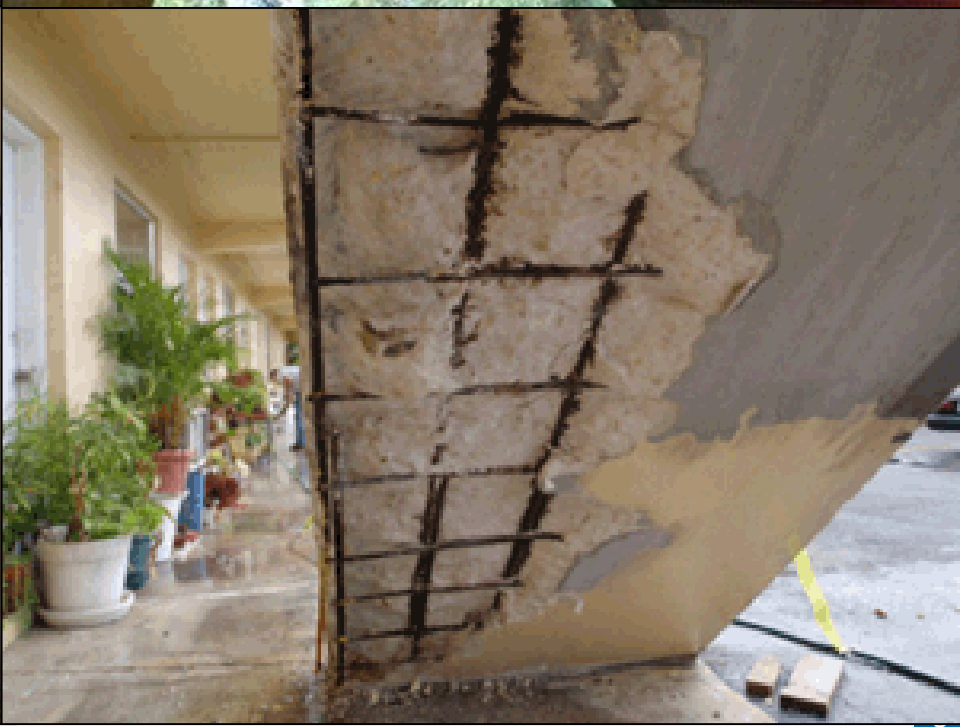
## A textbook case: Corrosion of the Turcot highway interchange in Montreal<sup>1,2</sup>

- A key interchange between Decarie (North-South) and Ville Marie (East-West) highways, built in 1966.
- Over 300,000 vehicles per day
- Made of reinforced concrete, badly corroded today by deicing salts

# It will have to be replaced

- In spite of constant supervision and repairs, it will have to be removed or partially replaced,
  - Cost estimate so far CAD 3000M.
  - Moreover, CAD 254M will have to be spent to ensure safety until its replacement in 2018
- Lifespan of the structure will be only 50 years!

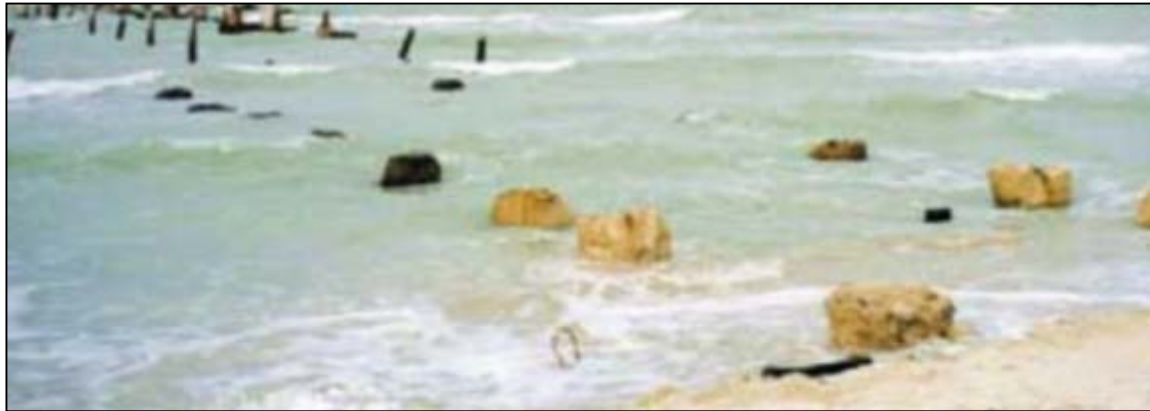
## The Progreso Pier (1/3)<sup>5,6</sup>

At Progreso, Mexico, a pier was built in 1970.

The marine environment made the carbon steel rebar corrode – the structure failed.

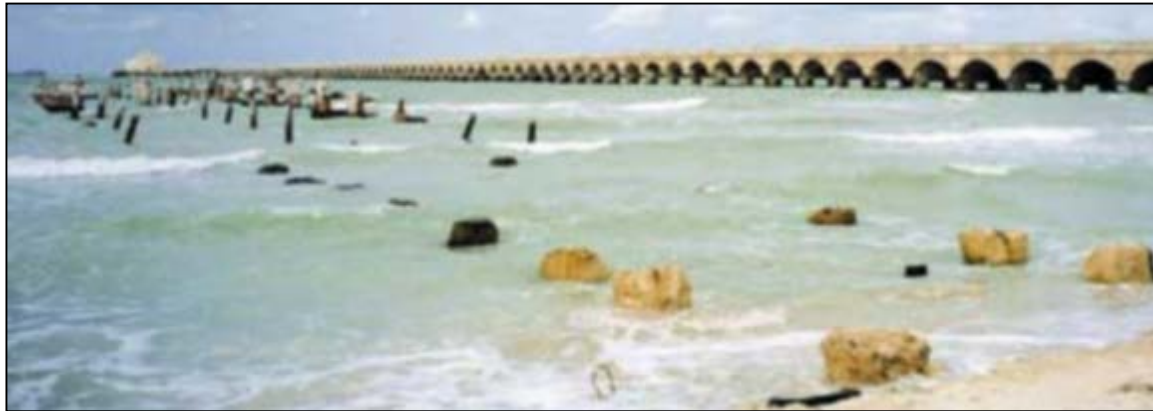
## The Progreso Pier (2/3)

The neighbouring pier had been erected in 1937 – 1941 using stainless steel reinforcement.

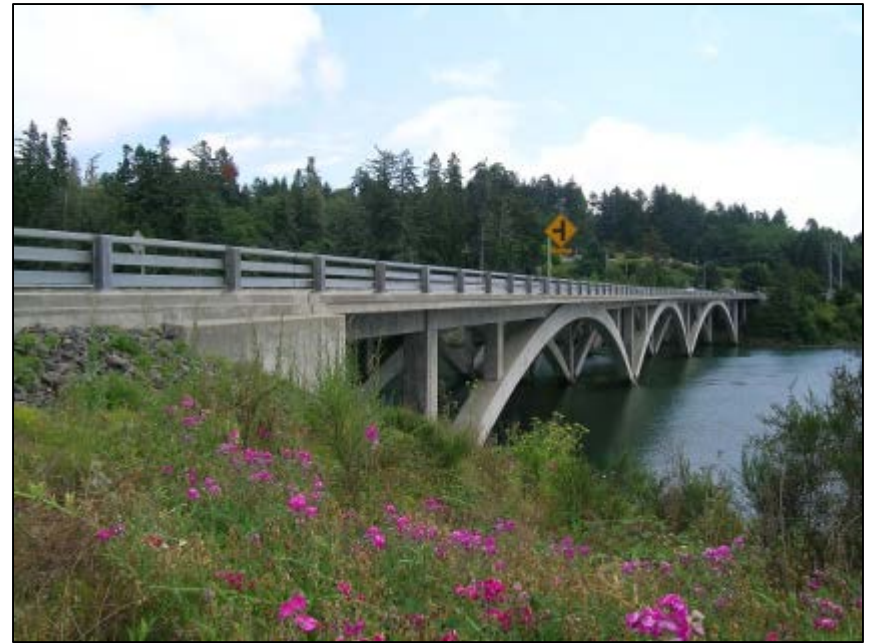
# Haynes Inlet Slough Bridge, Oregon, USA 2004<sup>7,8</sup>

An unusual arch-hinged bridge with 400 tons of stainless steel reinforcing bar in its deck.

The 230m-long link over Haynes Inlet Slough is expected to last 120 maintenance-free years.

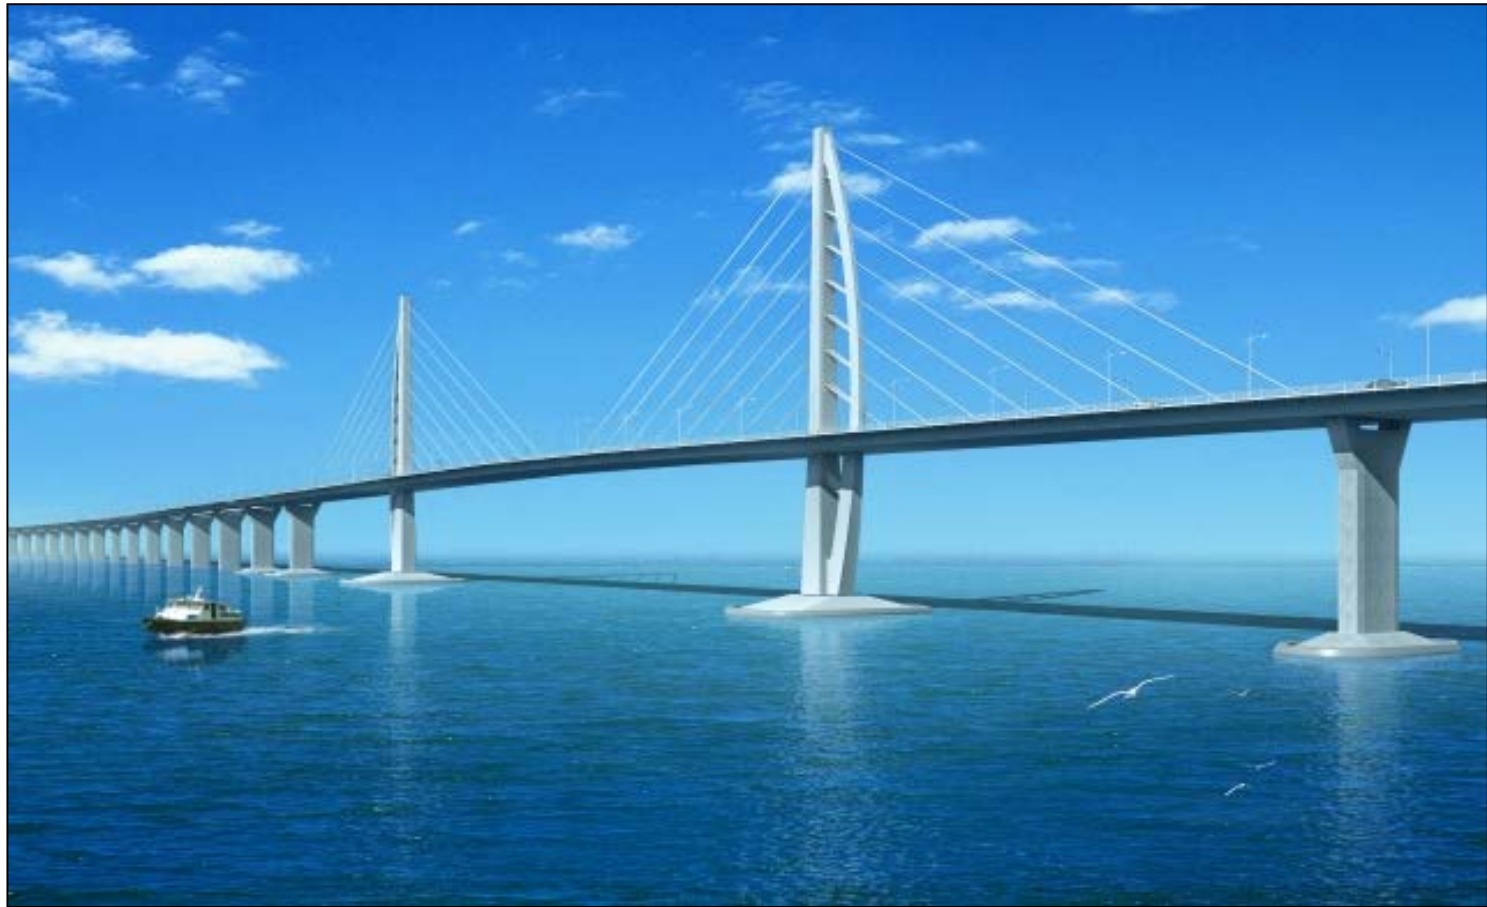
## **Hong Kong- Zhuhai- Macau Bridge<sup>9</sup> (construction began in 2009, to be completed in 2018)**

The prestigious Hong Kong- Zhuhai- Macau causeway project is one of the largest bridge projects in the world. The life time requirement is 120 years without maintenance. Therefore stainless steel reinforcement has been specified in the critical areas of the structure, mainly in splash zones. Eventually 15000MT of stainless will be used.

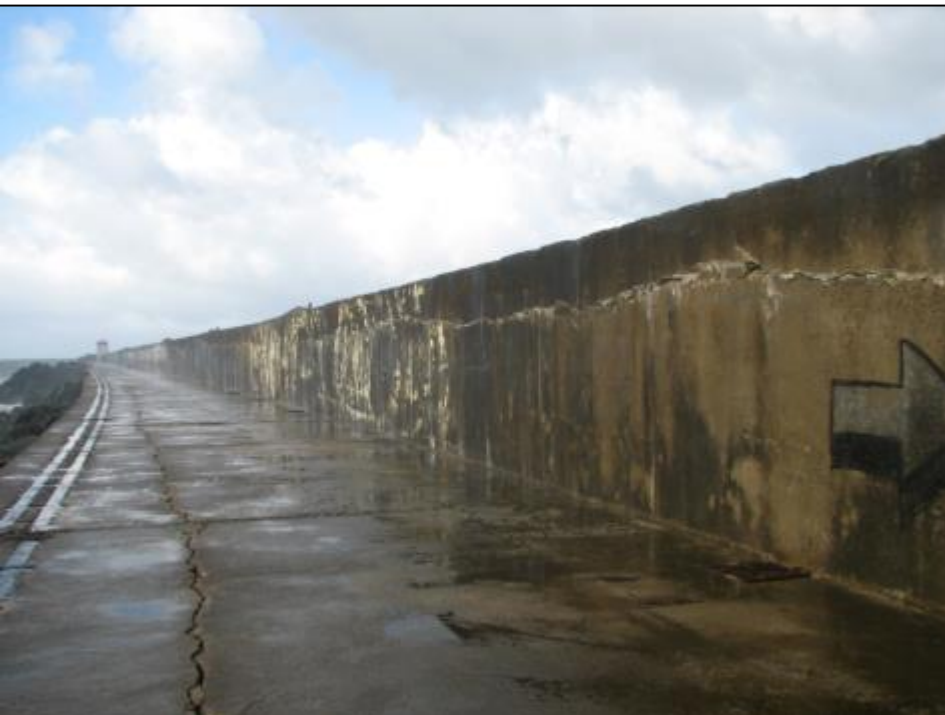
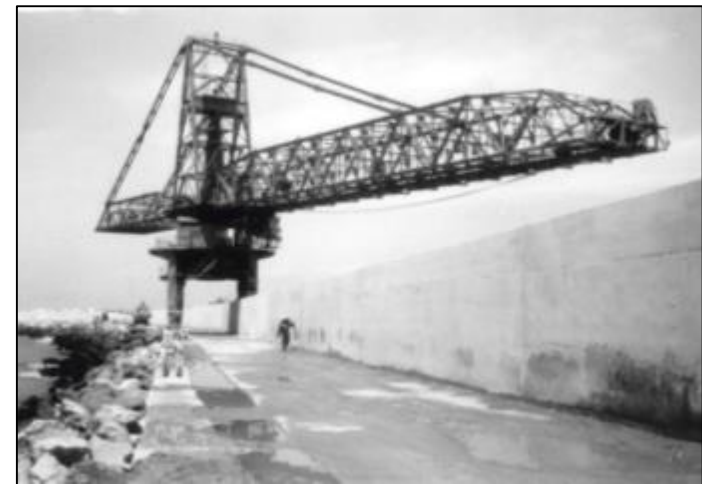
## Dam repair Bayonne, France

Dam built in the 1960s to protect the entrance to the harbour

The ocean side is higher and protected by 40T blocks which must be replaced as the storms wear them

On the river side a 7m wide platform allows the heavy-duty cranes to lift the blocks

Cracks on the deck and wall required repairs

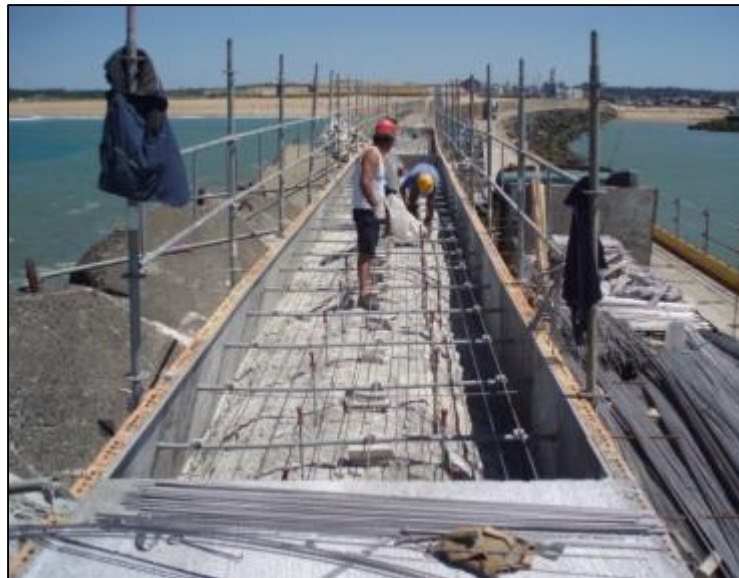
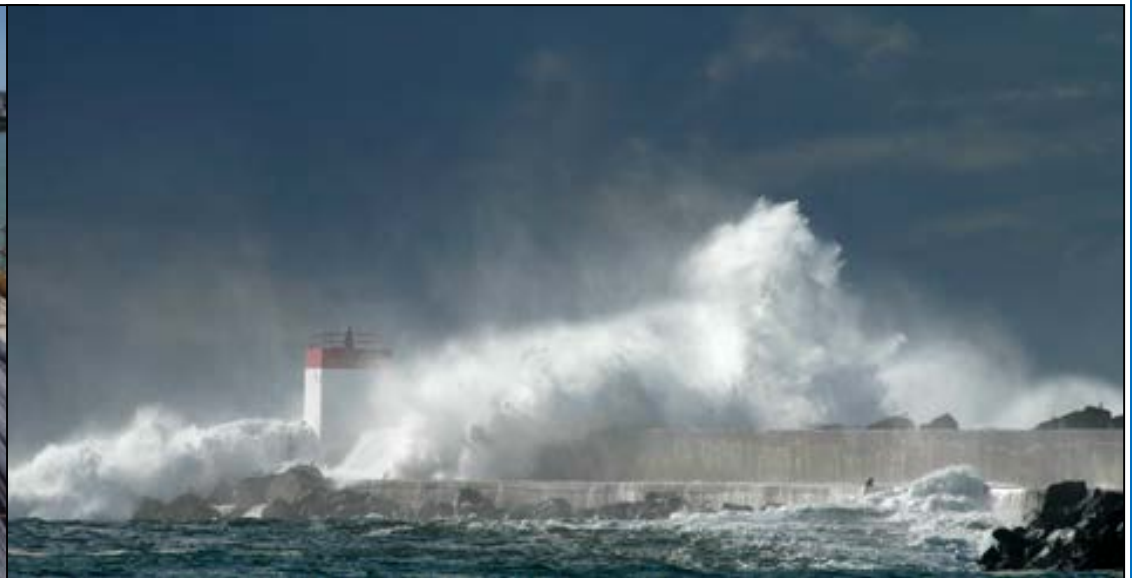
## Sea wall repair under way

## Early 2014 gale over the dam

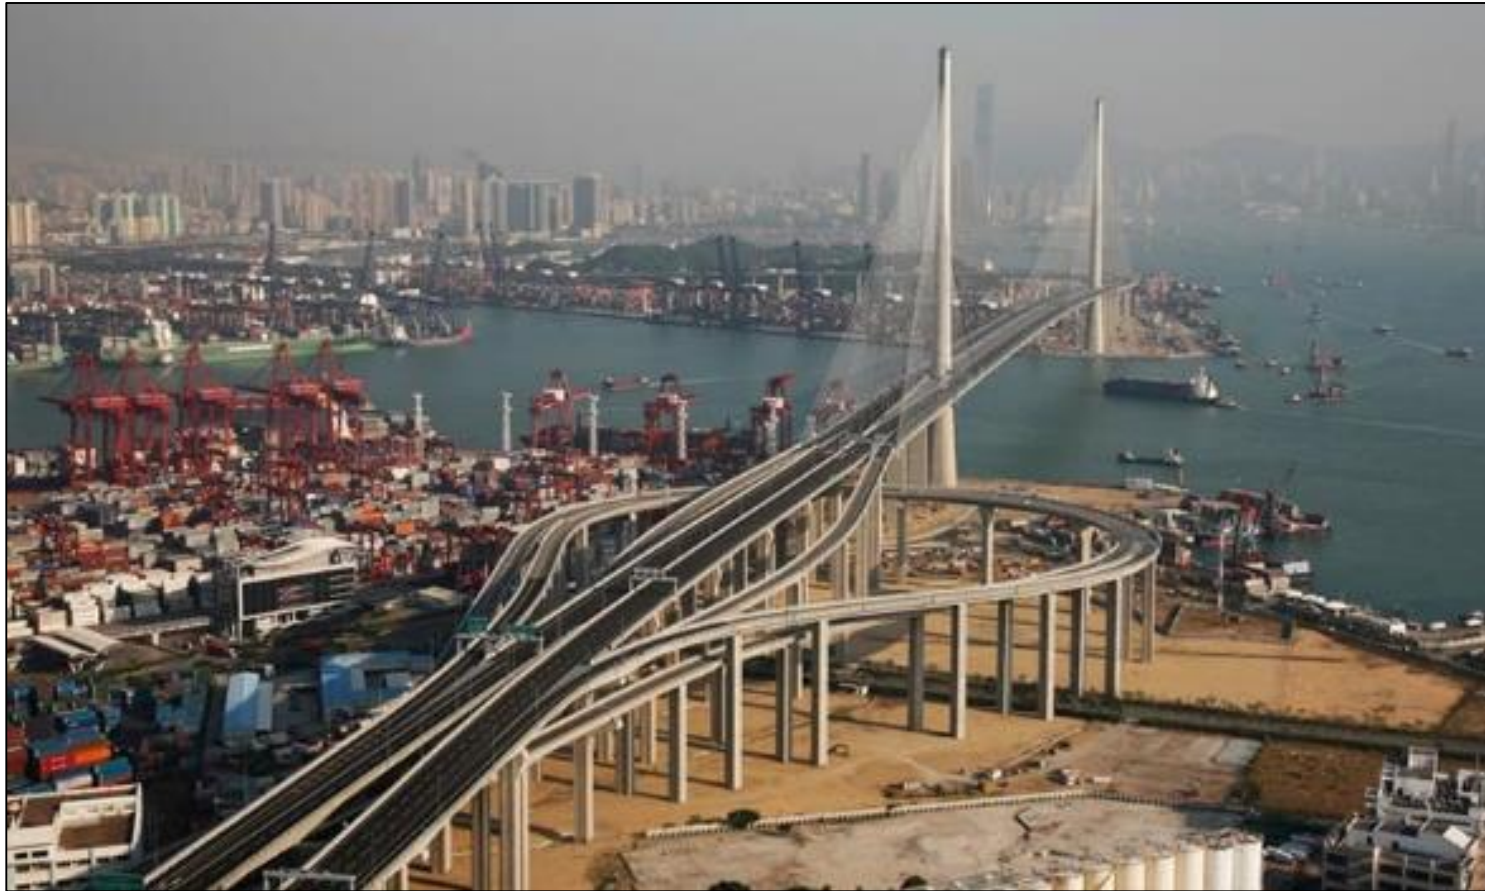
## Stonecutters Bridge Hong Kong<sup>12,13</sup>

The world's second longest spanning cable-stayed bridge, with a main span of 1,018m

The towers are 298m tall with 1,600 tonnes of structural stainless steel in the cable-stay anchorage zone and 2800 tonnes of stainless rebar in the reinforced concrete lower part of the towers.

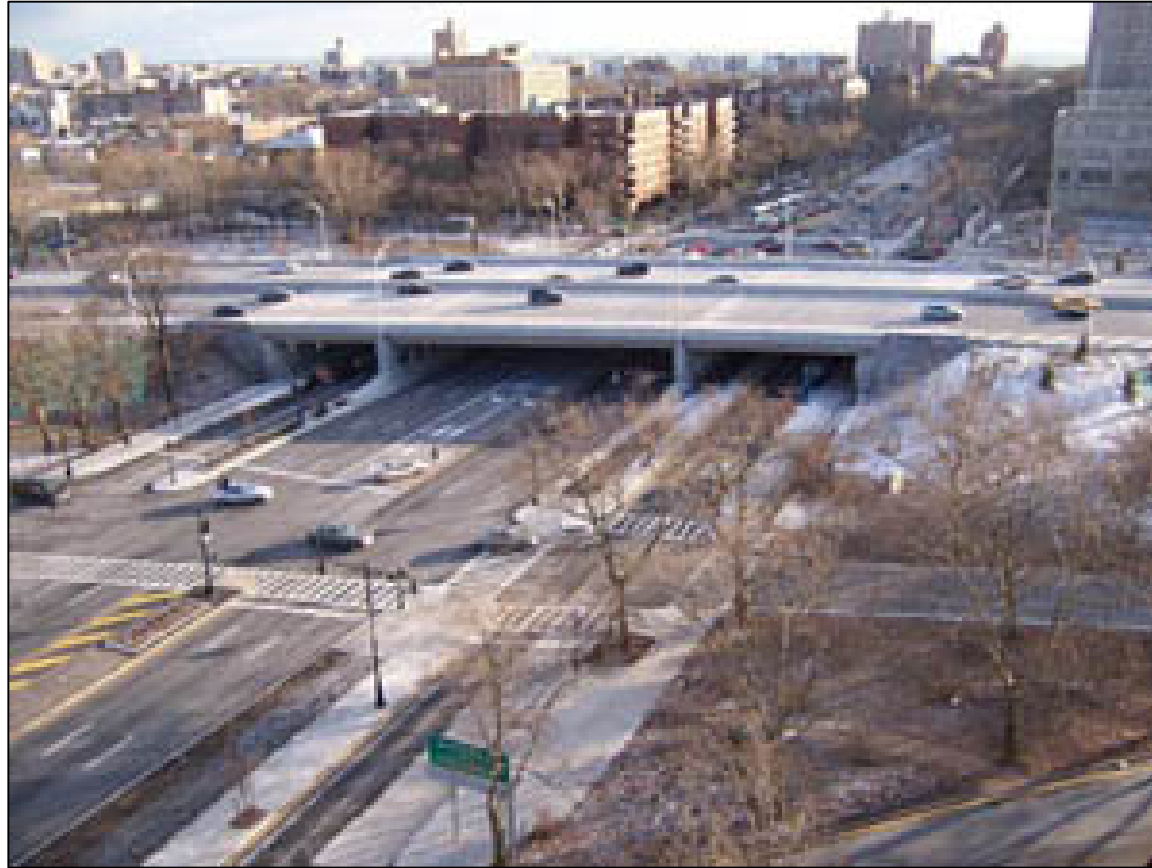
## **Belt Parkway Bridge, Brooklyn, USA (2004)<sup>14</sup>**

To assure long-term (100 years) durability and resistance to the corrosive attack of the area's marine environment and road salt, the bridge units and parapet barriers were reinforced with stainless steel grade 2205 rebar.
