Magnocentro Plaza Building

Mexico City, Mexico

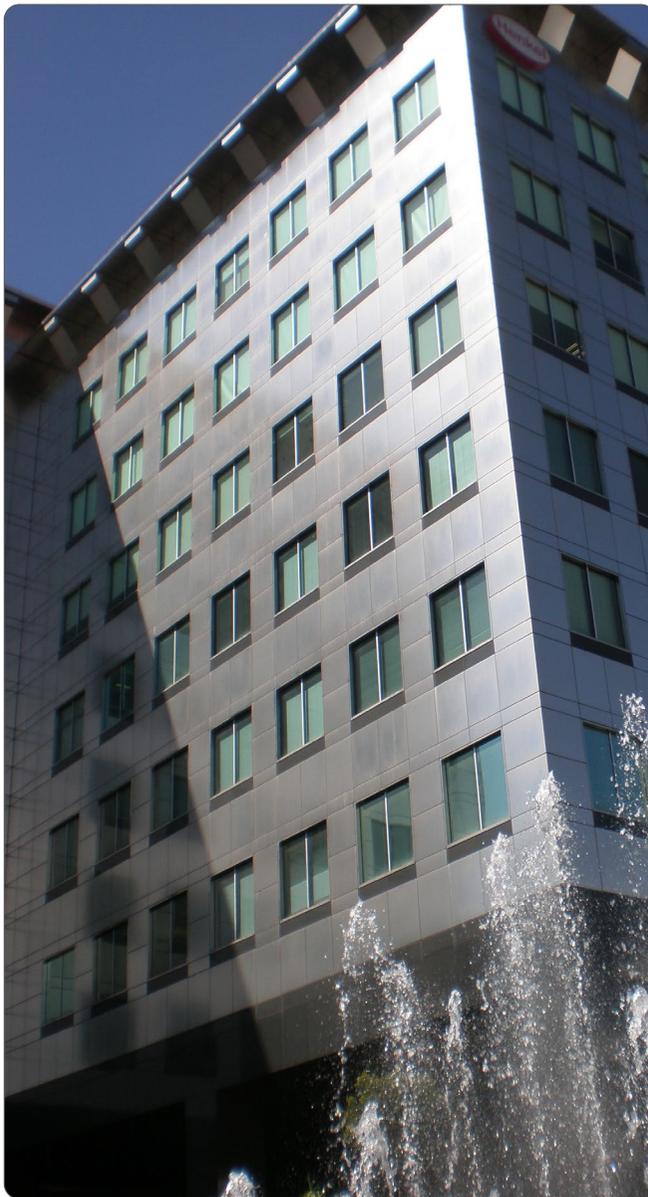
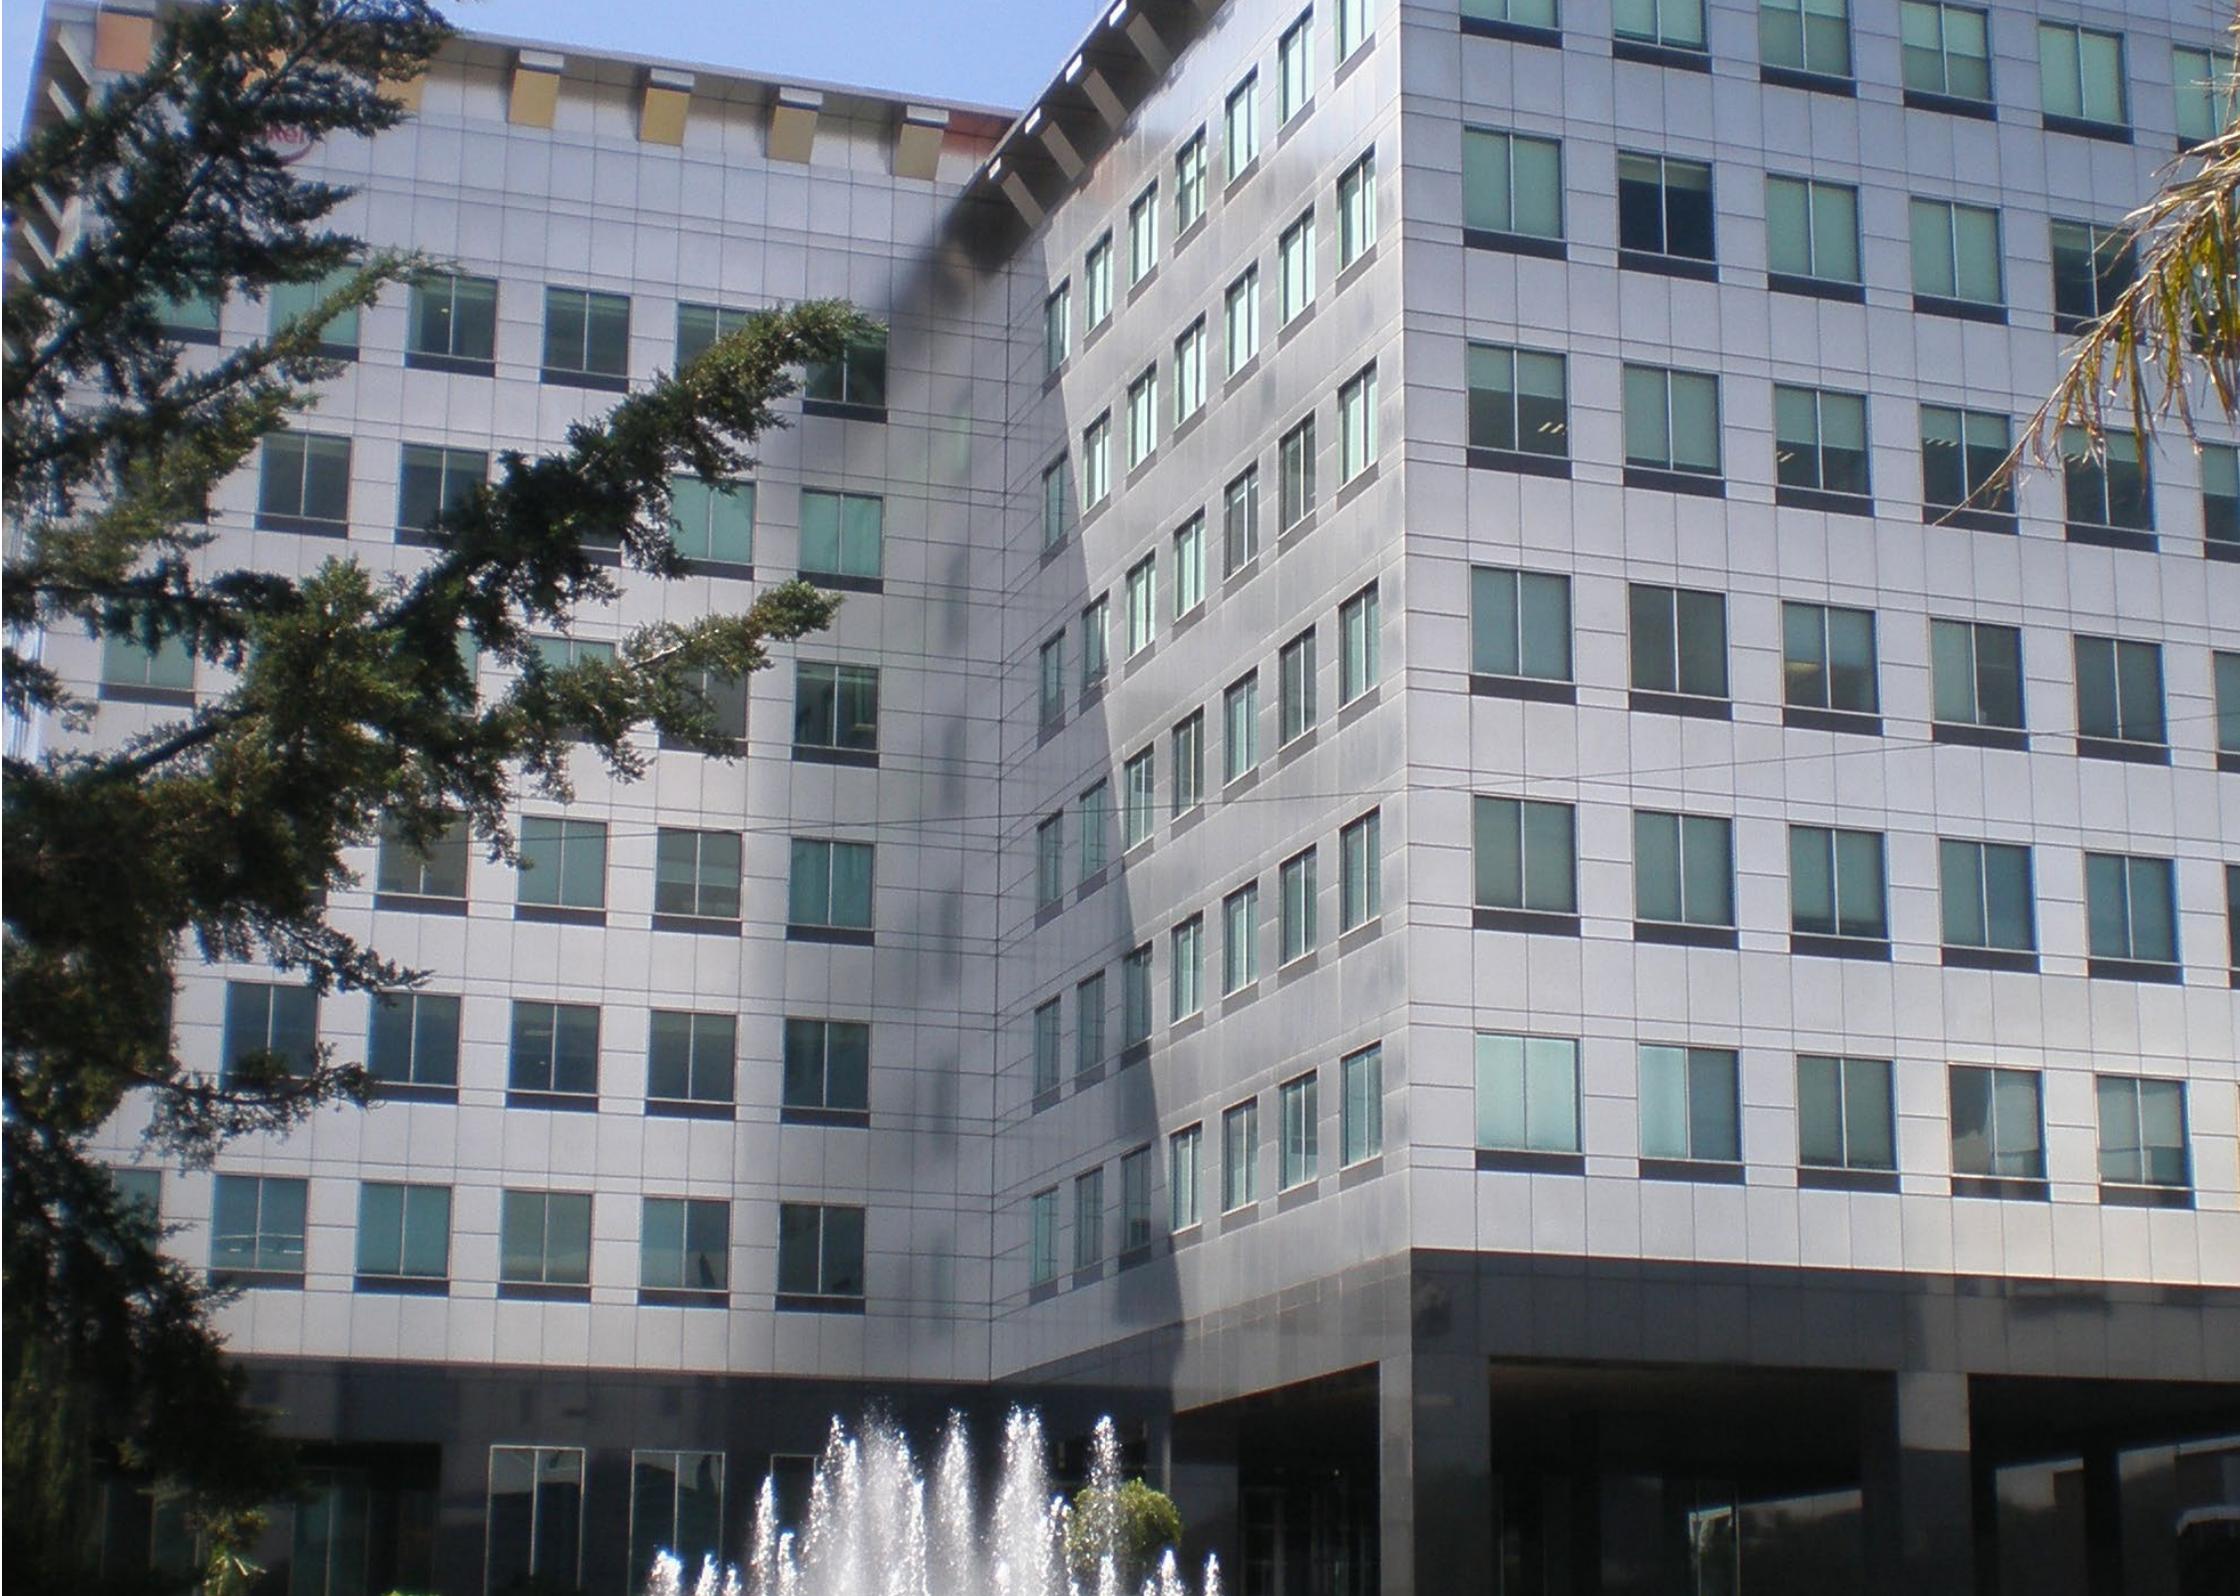
Environment:	urban
Material:	316 lino pattern finished stainless steel
Architects:	MEXDESA
Photographs:	MEXDESA
More information:	mexdesa.com or iminox.org

In 1997 PES Group did some research, it turned out that at that time it was more economical to use stainless steel than granite or other stone, hence the idea of covering the building with a stainless steel façade. Construction was finished in 2000.

Stainless 316 was chosen in order to prevent a quick deterioration.

Lino pattern finish was used to avoid dazzling people when driving because of the reflection of the sun on the façade. This pattern also hides any imperfections due to its "flatness".
