Magnocentro Plaza Building

Mexico City, Mexico

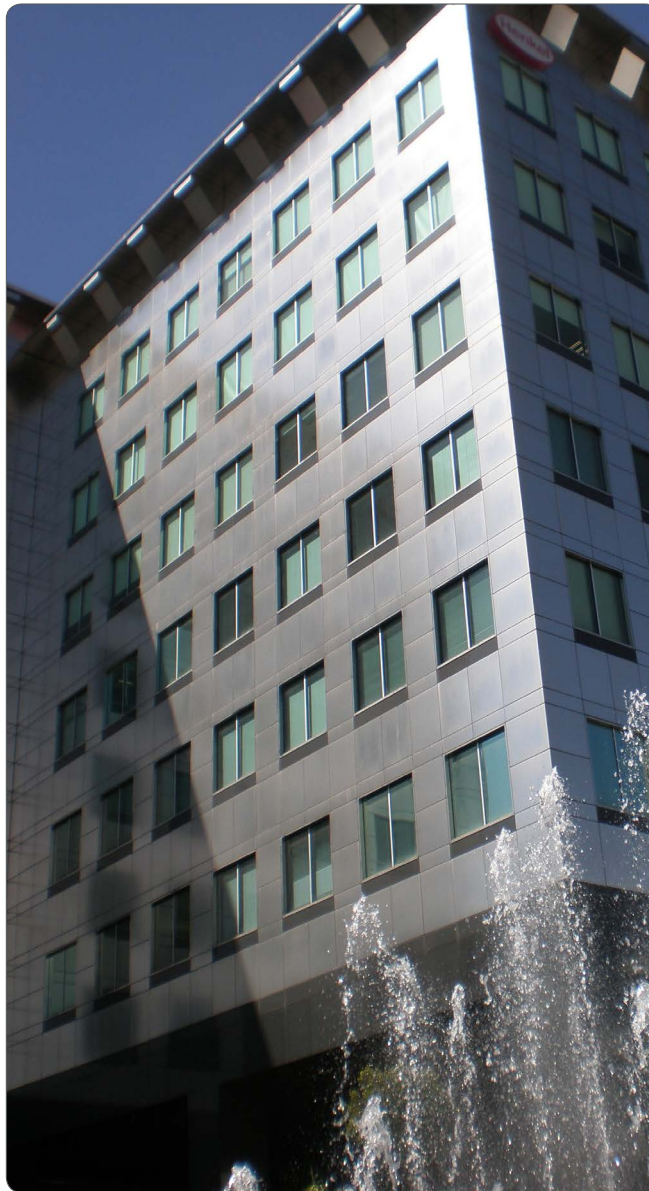
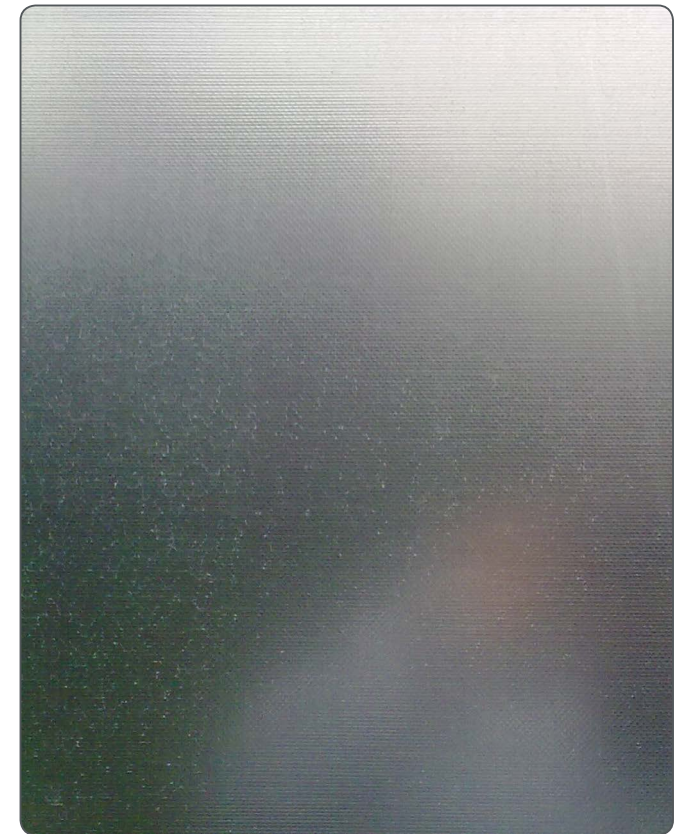
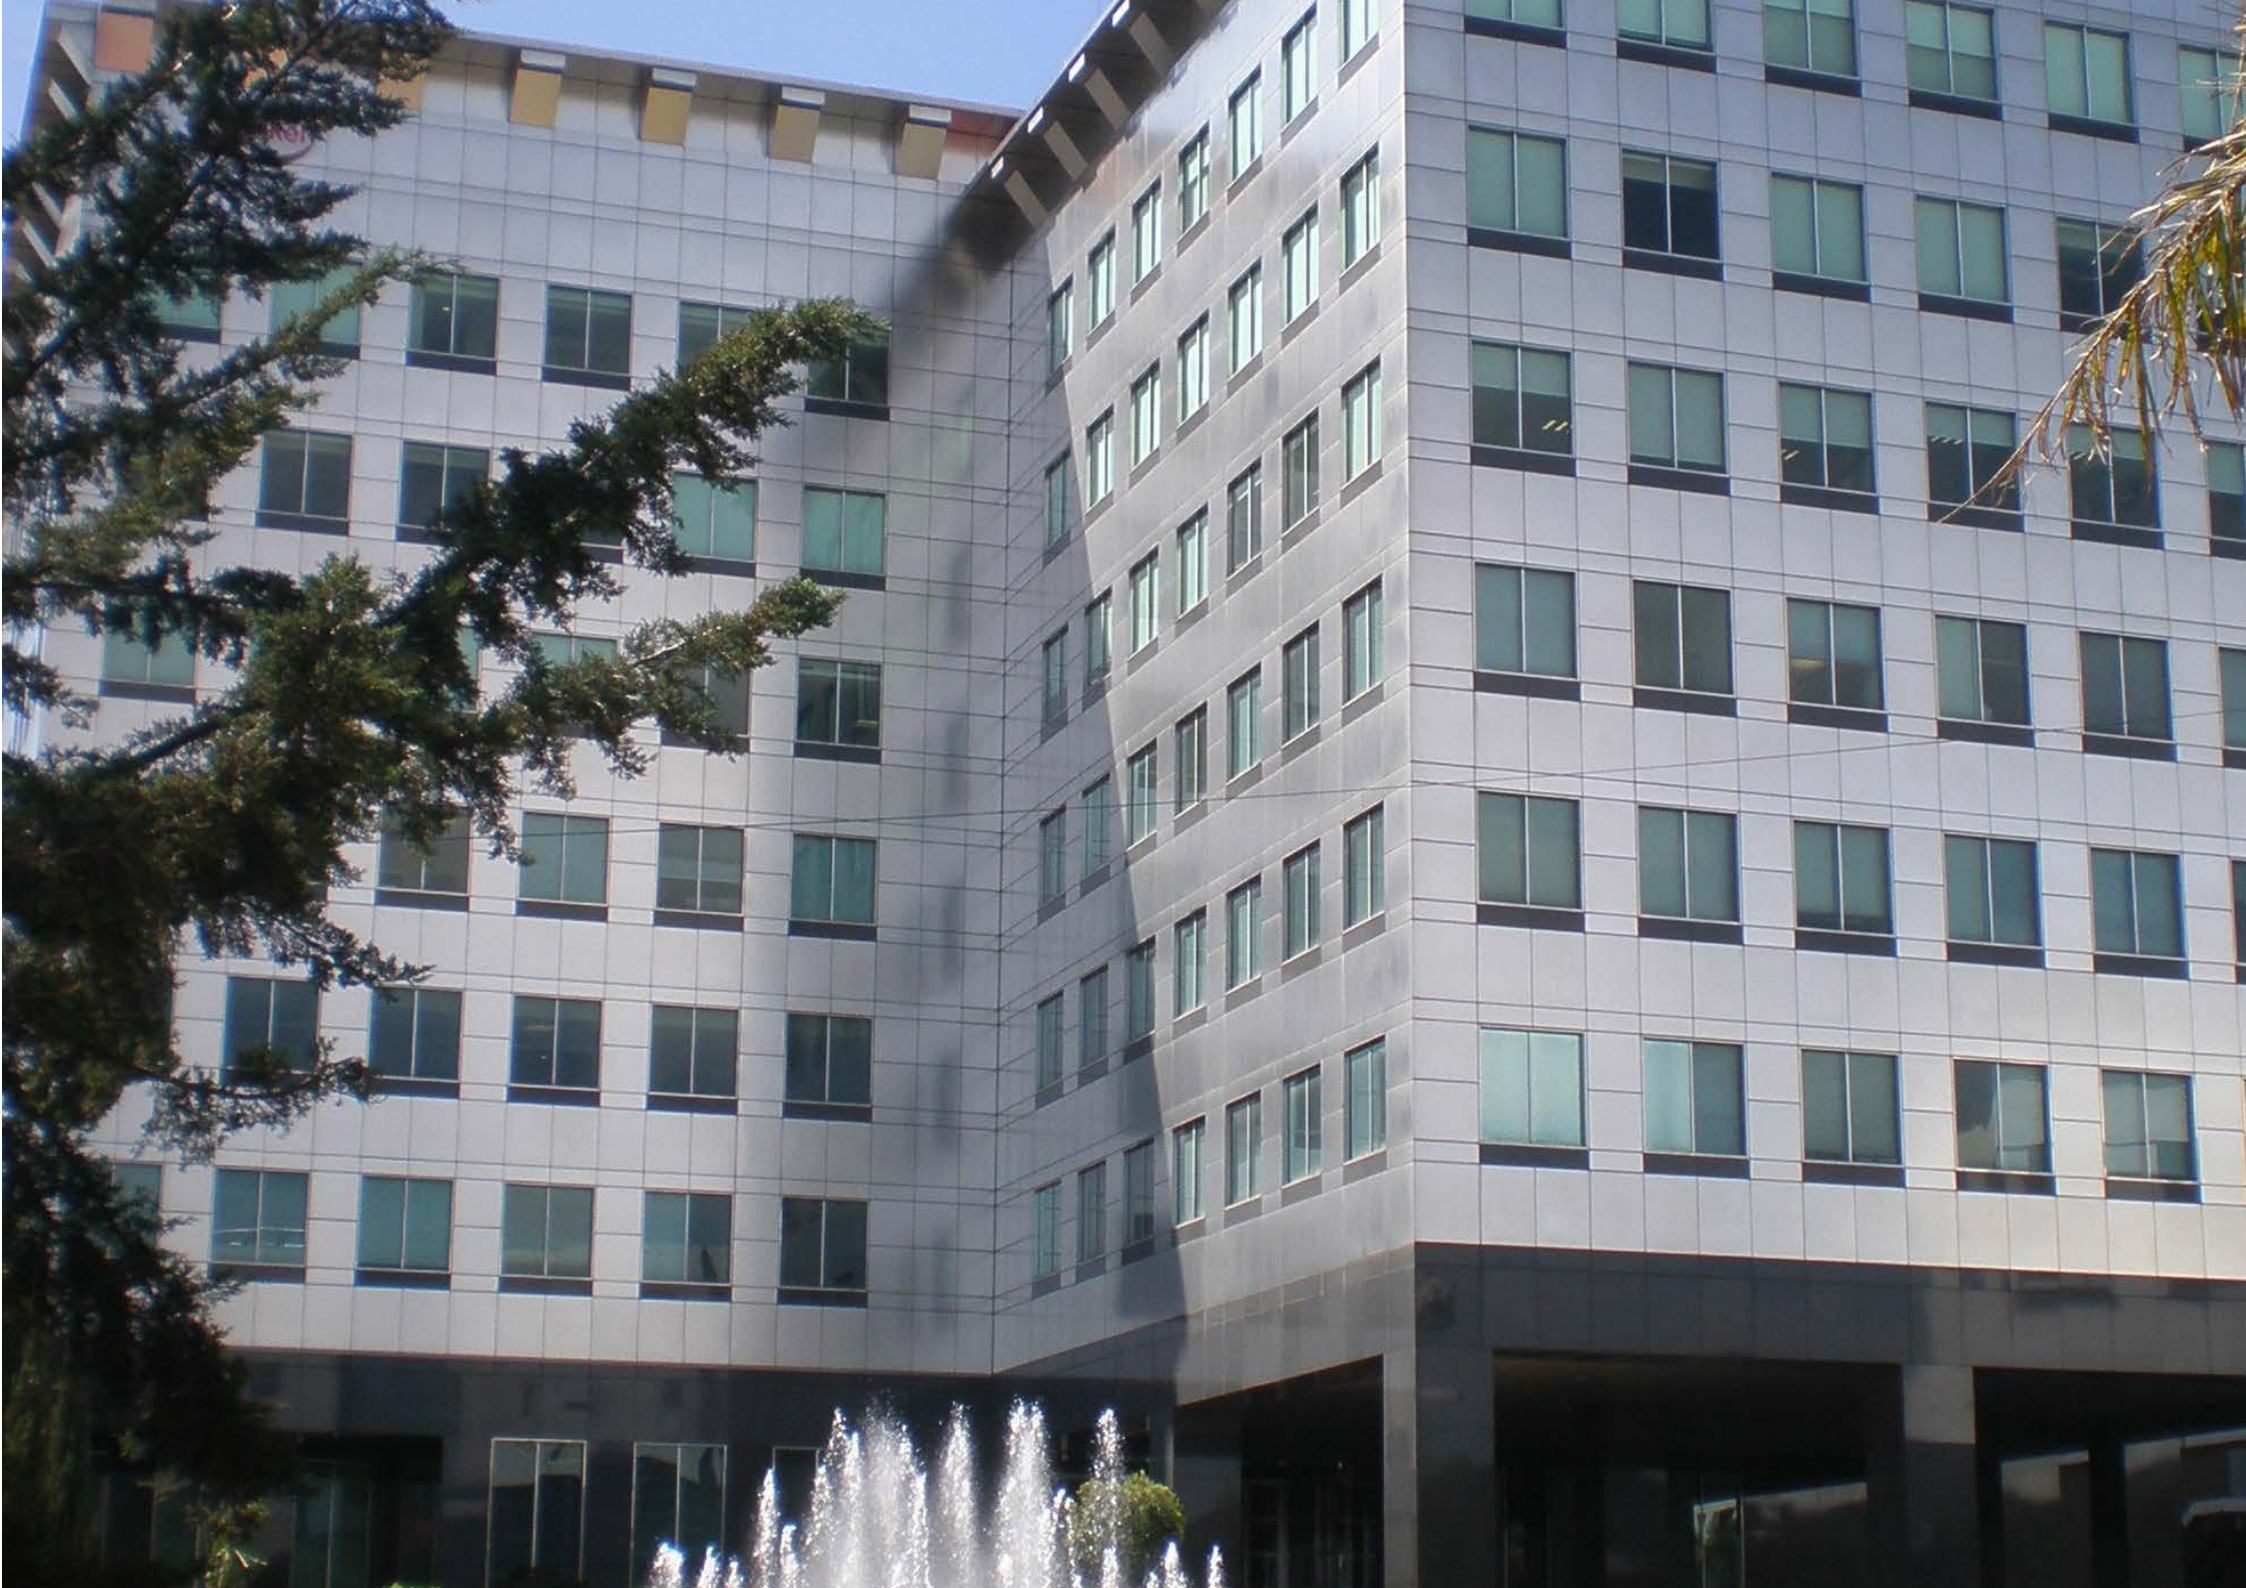
Environment:	urban
Material:	316 lino pattern finished stainless steel
Architects:	MEXDESA
Photographs:	MEXDESA
More information:	mexdesa.com or iminox.org

In 1997 PES Group did some research, it turned out that at that time it was more economical to use stainless steel than granite or other stone, hence the idea of covering the building with a stainless steel façade. Construction was finished in 2000.

Stainless 316 was chosen in order to prevent a quick deterioration.

Lino pattern finish was used to avoid dazzling people when driving because of the reflection of the sun on the façade. This pattern also hides any imperfections due to its "flatness".
