## Breakwater repair

### Bayonne, France

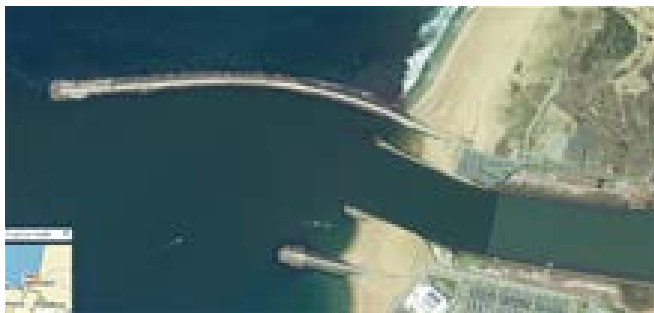
Aerial view

Being located at the Atlantic coast of France, the harbour of Bayonne is regularly exposed to stormy weather. In the 1960s, a breakwater was erected to protect the entrance channel. It included a wall and also a platform wide enough to accommodate a heavy duty crane used to place and re-position the 40 t concrete blocks that cover the exposed outside of the structure.

For the renewal in 2014, the authorities specified stainless steel and opted for the proven 22 % chromium, 5 % nickel duplex stainless steel grade whose additional molybdenum and nitrogen

contents provide superior corrosion resistance and mechanical properties. As grade EN 1.4462 in the ribbed condition has a minimum yield strength of > 750 MPa, rebar diameters could be reduced, which contributes to the overall economics of the stainless steel solution.
