Safety passage and blind spot camera - Prevention of contact accidents at outdoor loading area

Member Company NIPPON STEEL Stainless Steel Corporation

Category workplace improvement

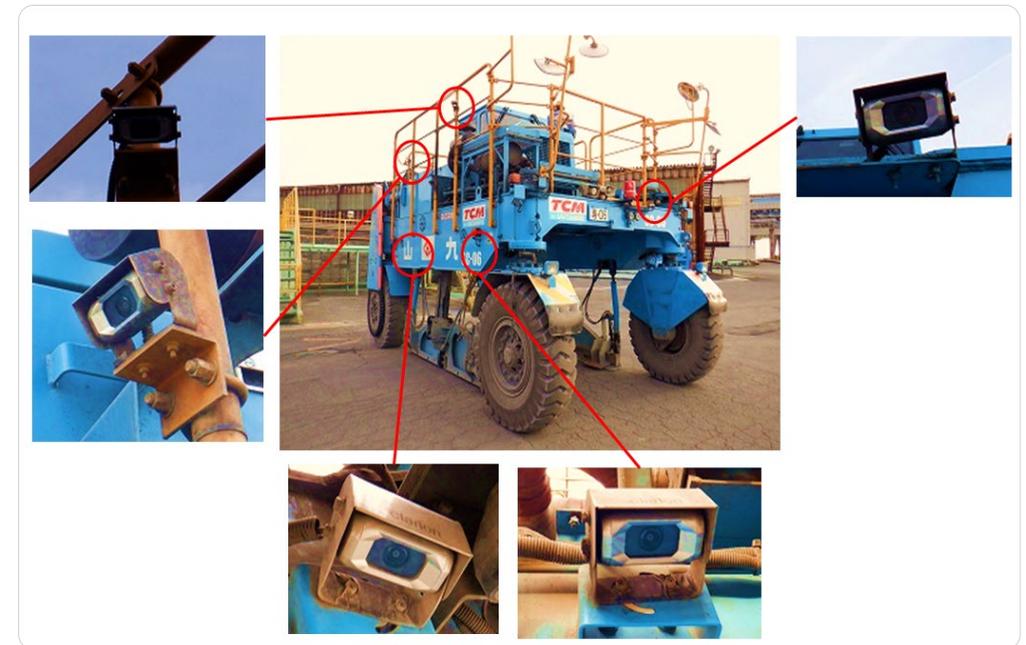
As a measure on the vehicle side, in order to eliminate blind spots from the driver's position in all logistics vehicles, five blind spot cameras on the straddle carrier and four blind spot cameras on the pallet car have been installed, and the driver can directly look at the blind spots of the vehicle on the monitor.

Picture 1: Positions of the blind spot cameras on the vehicle

Even when the logistics vehicle is not moving, the driver can always check the workers by using the blind spot camera, and the risk of the driver starting the vehicle without noticing the workers has been eliminated.

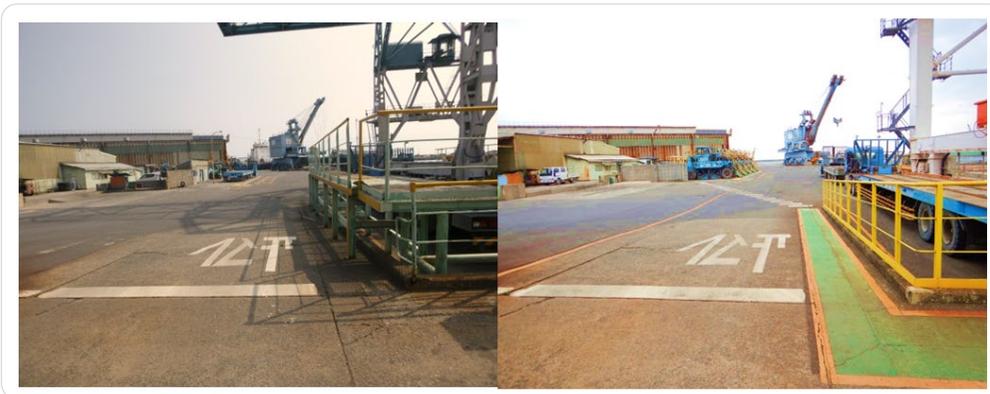
The total length of the safety passages was over 800 m and the traffic area for logistics vehicles and loading workers has been separated. By painting the passages in green, it is easier for the driver to see the workers on the passage.

Picture 2: The safety passage – Before and after at the shipping quay

As a measure on the worker side, safety passages and traffic rules for workers were established to prevent workers from entering the work area of the vehicles.

When establishing the measures taken, the loading workers and the logistics vehicle drivers discussed the details of their work and mutually confirmed the work area of the vehicles. The route of the safety passages was decided so that both workability and safety were achieved.
