## Governador Plácido Castelo Stadium - Castelão Arena

### Fortaleza, Ceará, Brazil

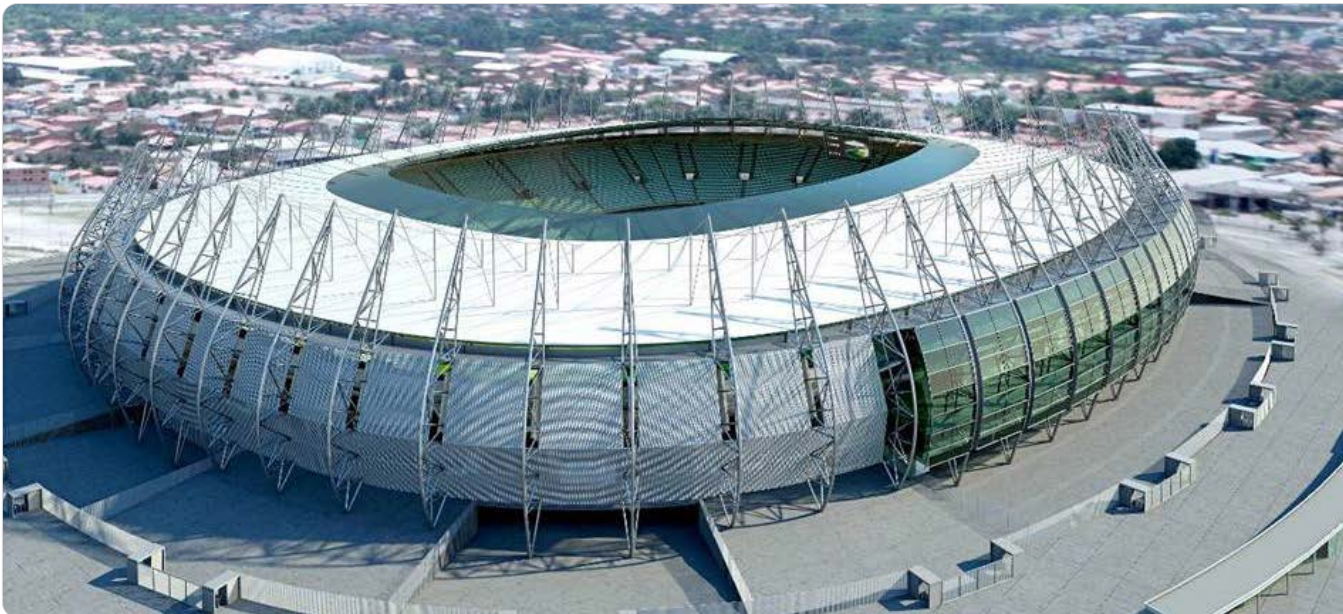
The stadium in Fortaleza city in the North East of the country, called Castelão, hosted six World Cup matches. Designed for 64,000 persons and initially opened in 1973, it recently went through two years of refurbishments. The façade was entirely rebuilt using stainless steel stretch metal. The principle: by slitting sheet metal and expanding it, the material naturally shapes into a structurally optimal geometry. The stretching process is carefully controlled to produce

the desired ratio of open and closed surfaces. Although the original 2B surface used is quite bright, the reflection of the stretch metal is diffuse. It reflects heat away from the building without causing glare. The molybdenum-bearing ferritic grade 444 was found to be technically and economically an optimal solution for the environment. In addition to the external frame, stainless steel was used on railings, handrails at VIP areas, lavatories and locks of the stadium.

Environment:	urban outdoor
Fabrication process:	stretch forming
Grade and finish:	444, 2B
Total weight of the stainless steel used in the project:	80 tons
Date of completion:	2012
Manufacturing company:	Martifer, Fortaleza, and Permetal, Ribeirânia, Ribeirão Preto
Architects:	Viglicca & Associados, São Paulo (refurbishment)
Material supplier:	Aperam South America
Photographs:	Aperam South America
More information:	<a href="http://aperam.com">aperam.com</a>
