Malinka Gallery

History of the project

Location: Naramata, BC, Canada

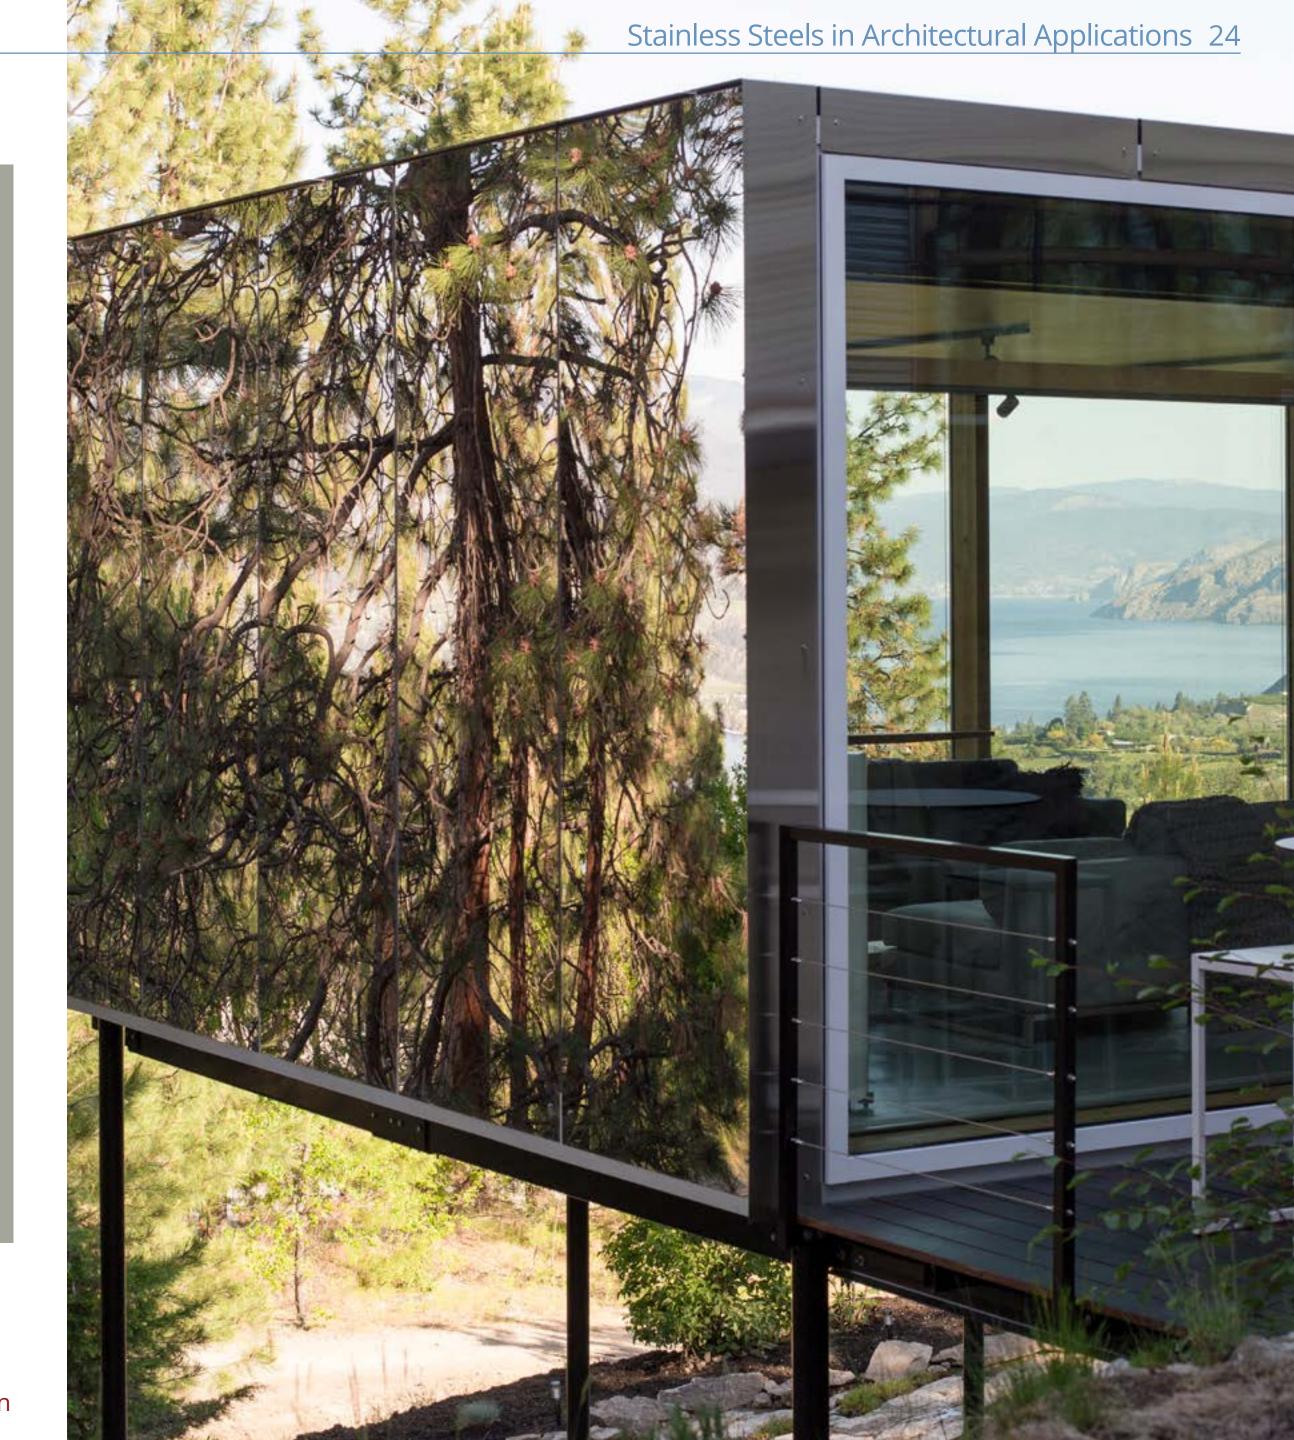
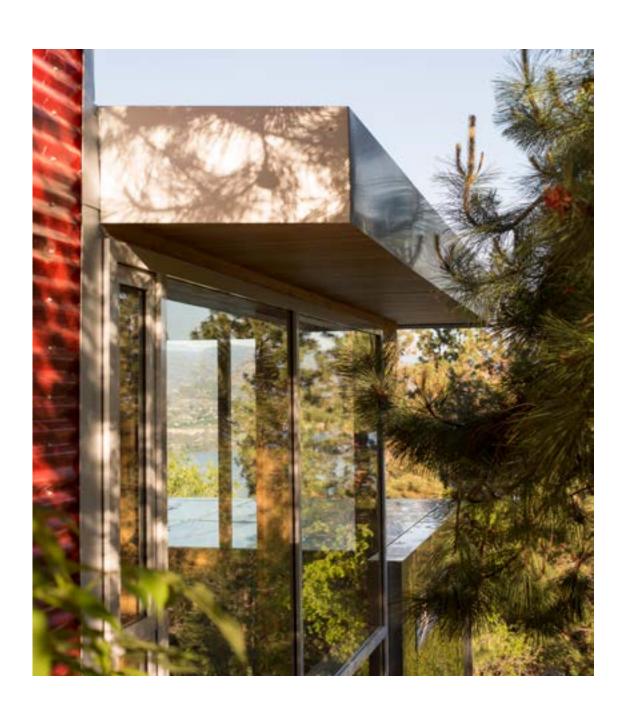
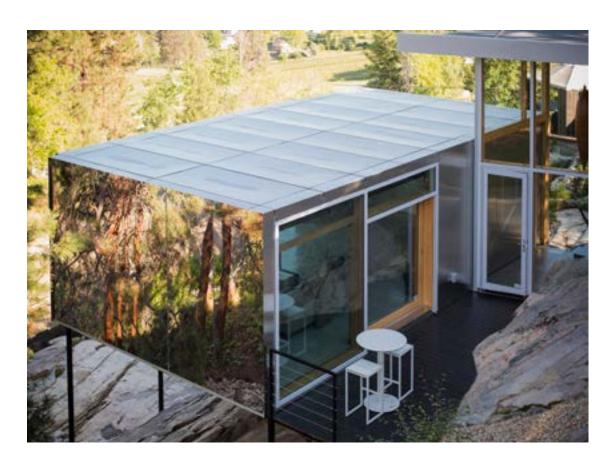
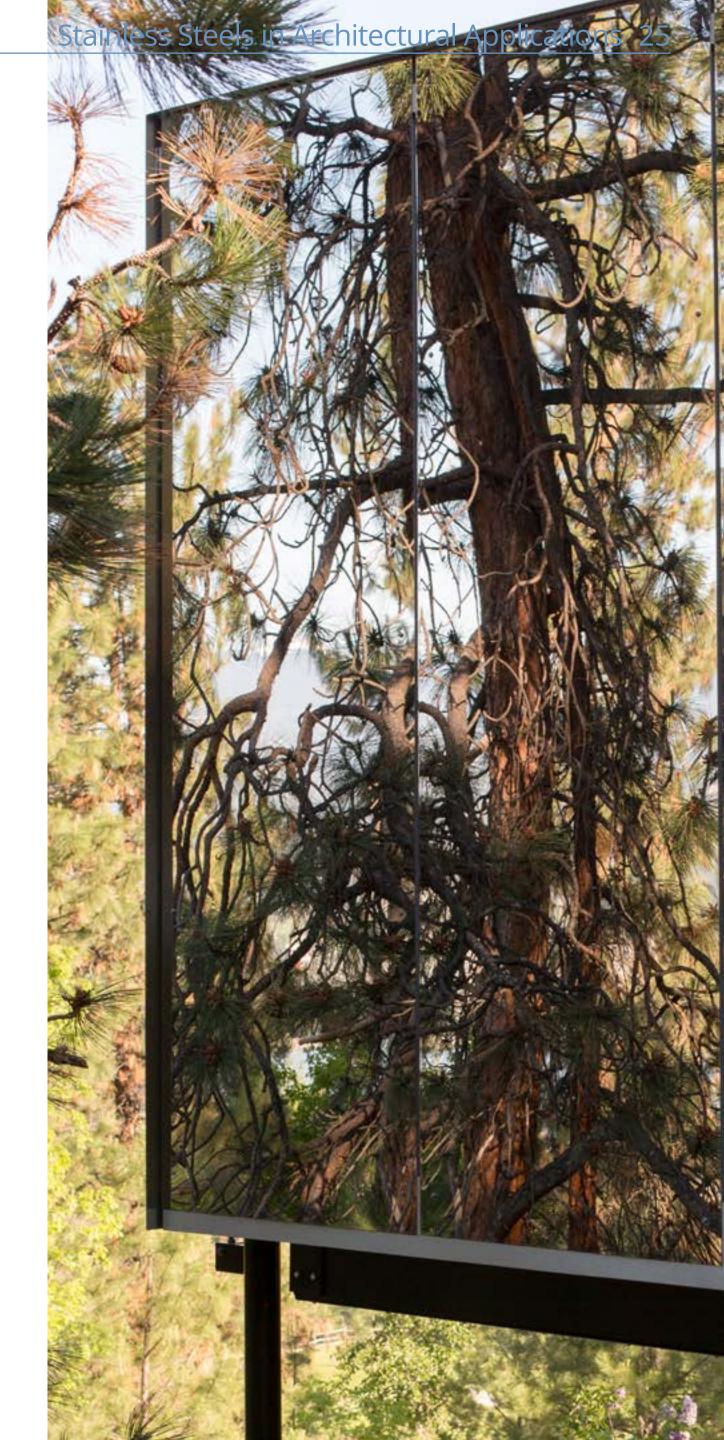
The slope to the west allowed a low profile addition to be placed just low enough to maintain lake views across its roof from the main house. Slim steel posts support the gallery structure. Clad in stainless steel and reflecting sky and forest, it seems to float above the bedrock, fitting its grassland context gently. The disappearing

The owners would have gladly accepted another small free-standing structure to match the house's original concept, but local zoning would not allow additional structures, so the gallery had to be connected to the original house by a stairway. The stair hall glazing slotted into bedrock and stainless-clad gallery roof contrast the original house's simple thresholds and exterior woodwork. The stair bridges from the living house to the gallery, an abstract space from which to observe the original architecture now exhibited alongside the owner's collection of paintings and sculptures.
